# Friction and Parking Lots

Technical Bulletin, Volume 3 September 2020

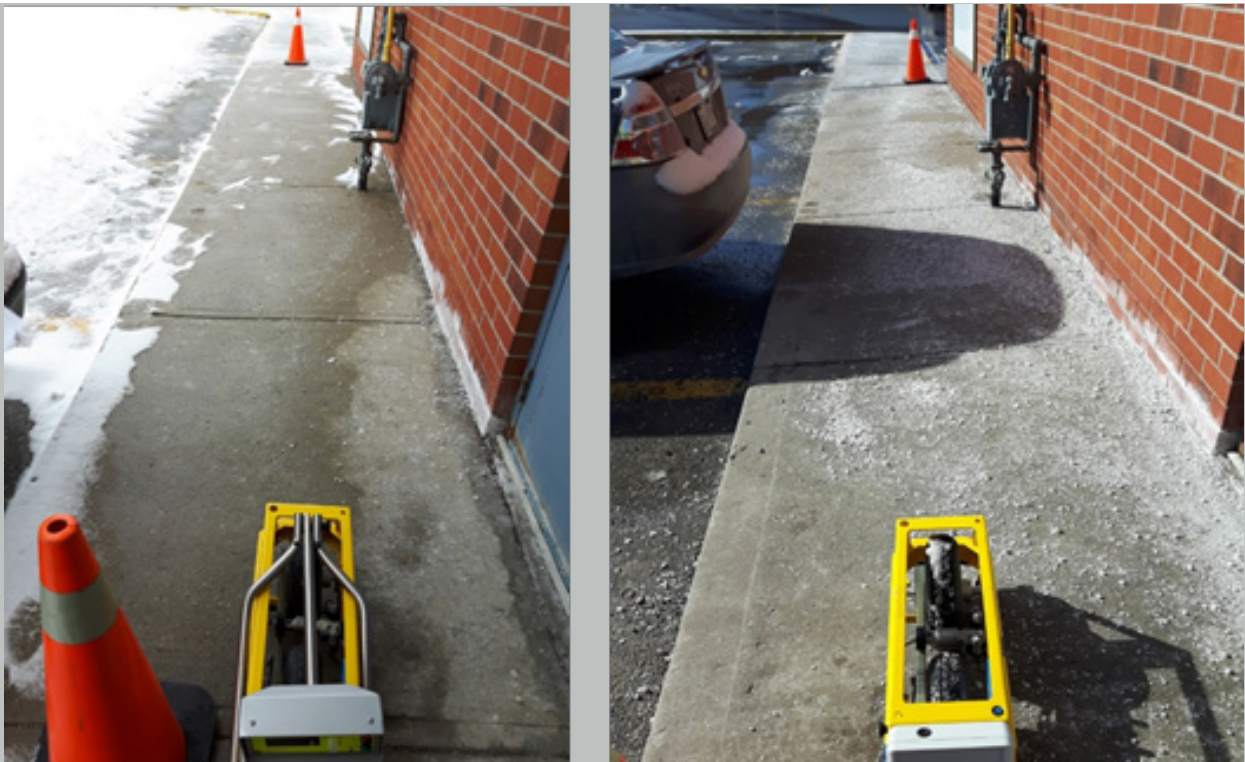
Figure 2: Friction values for a properly treated surface  $\mu = 0.63$  (left image) and an oversalted surface  $\mu = 0.26$  (right image)

High volumes of salt are often applied because contractors, the property managers hiring them, and/or the general public feels that the more salt there is, the safer the surface is. Figure 2, however, demonstrates empirically that a properly treated surface in the photo on the left, which is slightly wet with a small amount of salt residue ( $\mu = 0.63$ ) is actually far safer than the photo on the right where the salt has been heavily applied ( $\mu = 0.26$ ).

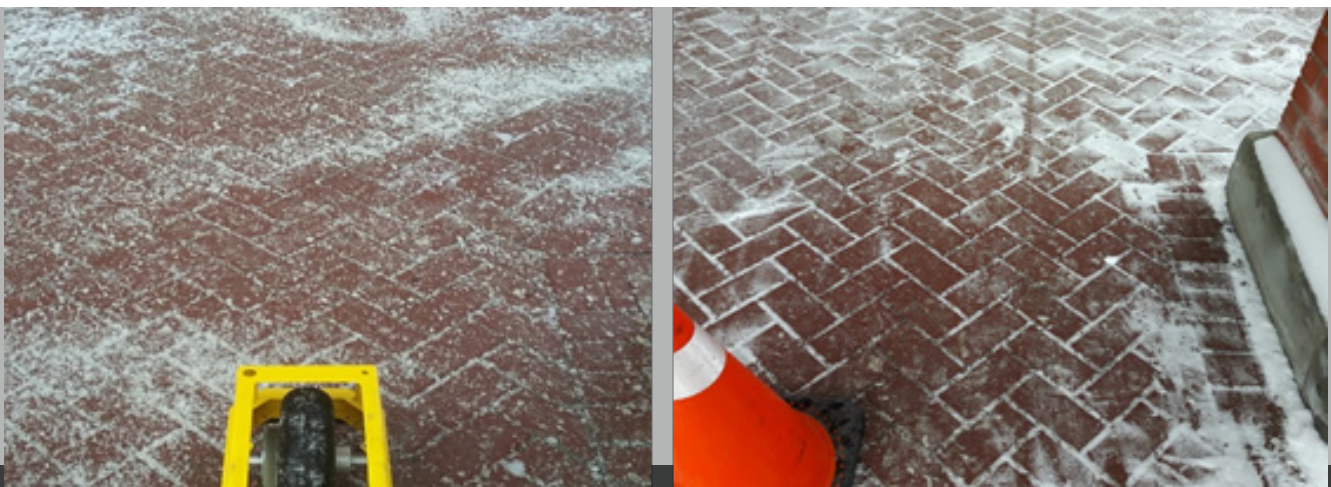
Figure 3: Similar  $\mu$  values were measured for an oversalted walkway (left image), and the same walkway which has had the snow shoveled off (right image).

Through this work, LSRCA staff were also able to demonstrate that while excessively high volumes of salt are no safer than many untreated surfaces, the  $\mu$  value of a surface may still remain low if it has only been shoveled or plowed. Figure 3 displays a walkway where more than 10 times the generally recommended amount of salt was applied in the photo on the left, and only shoveling was done in the photo on the right, and both  $\mu$  values were in the low 0.20s. This demonstrates that while shoveling is an important part of the winter maintenance process, practitioners need to consider the site and predicted conditions on the day to determine how to attain the safest surface. In many cases the sun or traffic may melt the residual snow on a shoveled or plowed surface without any further treatment being necessary; while in other cases, some salt, applied at an appropriate rate, may be necessary.
