2018

USING WILDLIFE ECOPASSAGES TO REDUCE TURTLE ROAD MORTALITY IN THE LAKE SIMCOE WATERSHED

Lake Simcoe Region
conservation authority

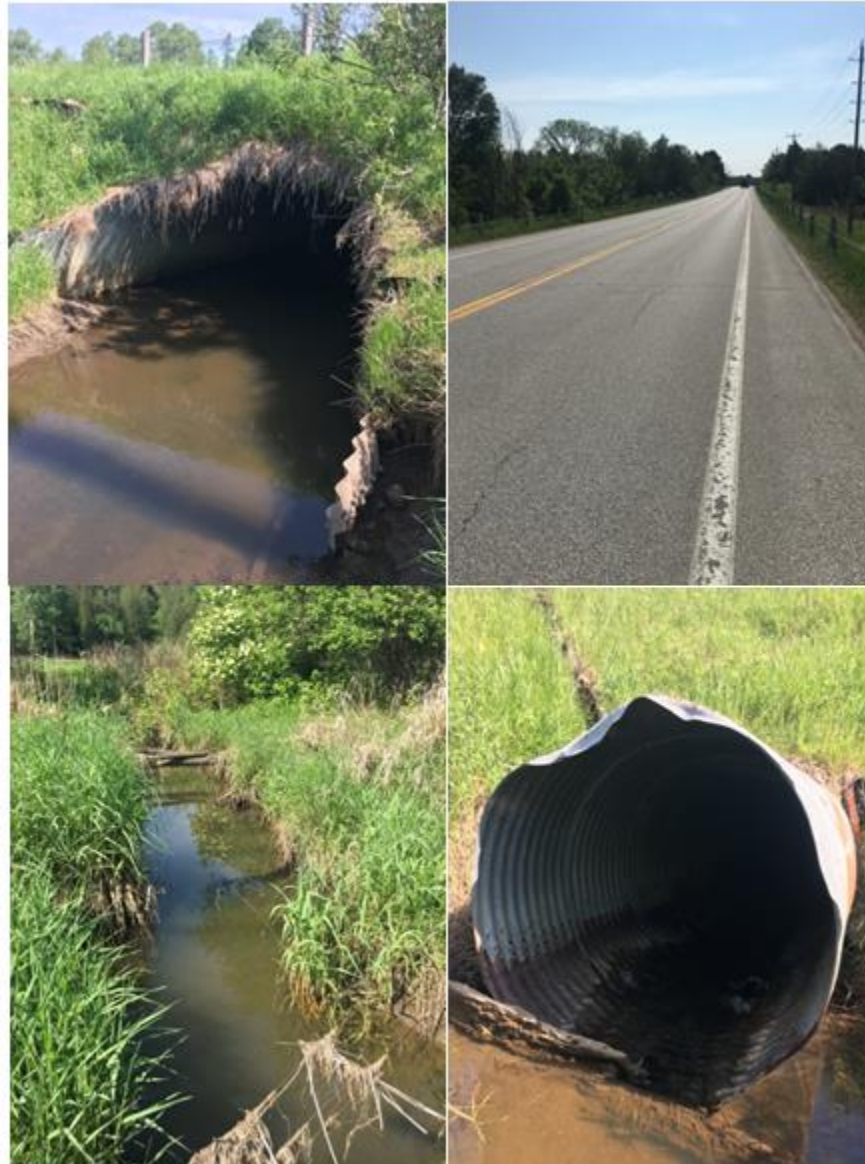
The South Schomberg River crosses under the road at two locations at this site. One crossing consists of a flared corrugated steel pipe (CSP) measuring 4.3 m in diameter and approximately 24.8 m long,

corresponding to an openness ratio¹ of 0.58. The second crossing is a 1.2 m diameter CSP, measuring approximately 28.4 m long, with an openness ratio of 0.04. Openness ratio refers to the amount of light visible at the end of a crossing structure and determines the permeability or attractiveness of a structure for wildlife to cross through. A higher value means a more attractive crossing structure, and an openness ratio greater than 0.25 is recommended for turtles, but no less than 0.1.

Figure 2. Photos of Site 1, clockwise from top left: view of larger culvert, looking north; view of road, looking east; South Schomberg River, looking south; view of smaller culvert, looking north

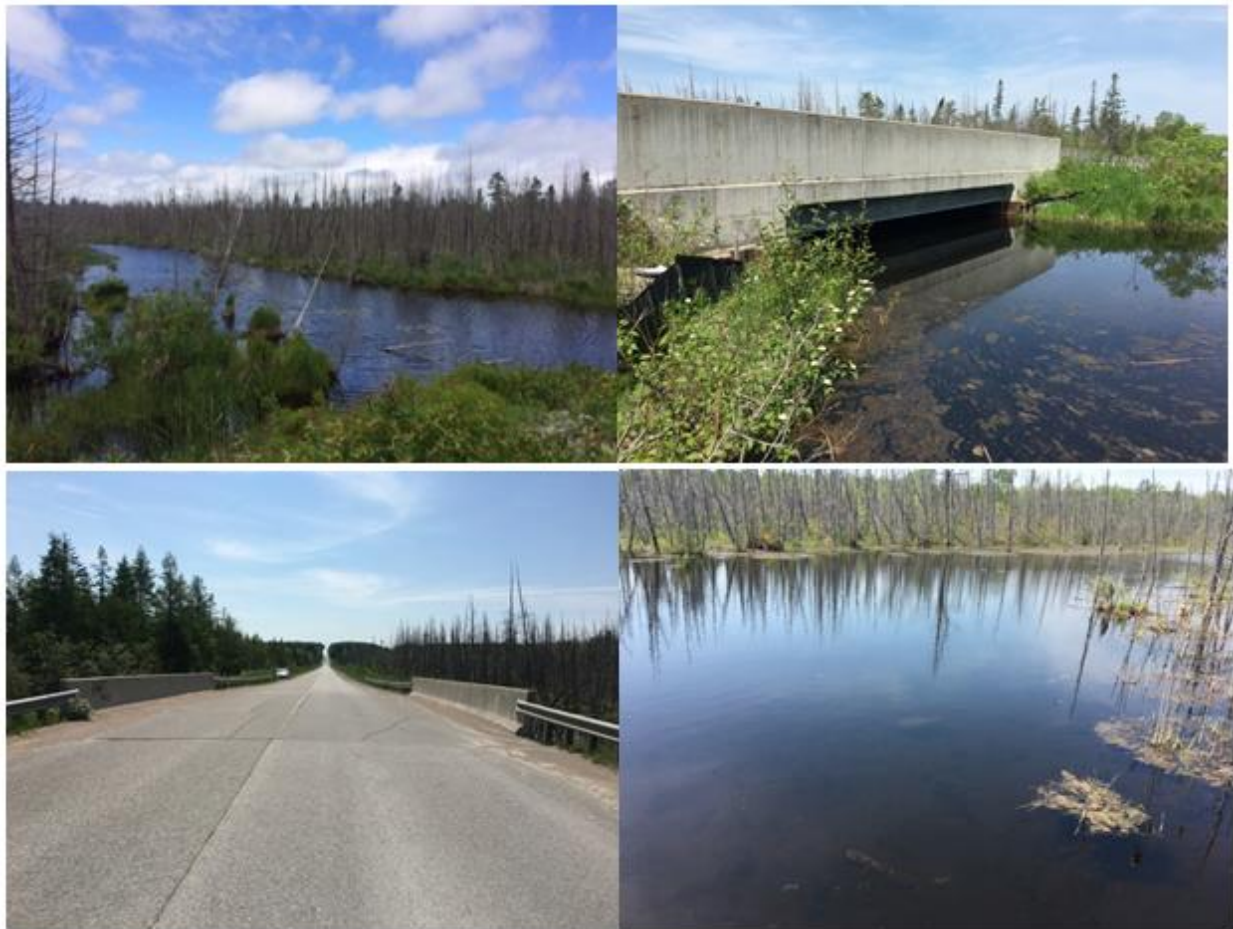
The road crosses through the Hawkestone wetland complex, and at this site Hawkestone Creek flows under the road through a bridge with an opening measuring approximately 1.82 m high, 8.58 m wide, and 12.5 m long (openness ratio² of 1.25).

Figure 3. Photos of Site 2, clockwise from top left: wetland west of the site; crossing structure, looking west; view of site, looking south; snapping turtle in wetland on west side

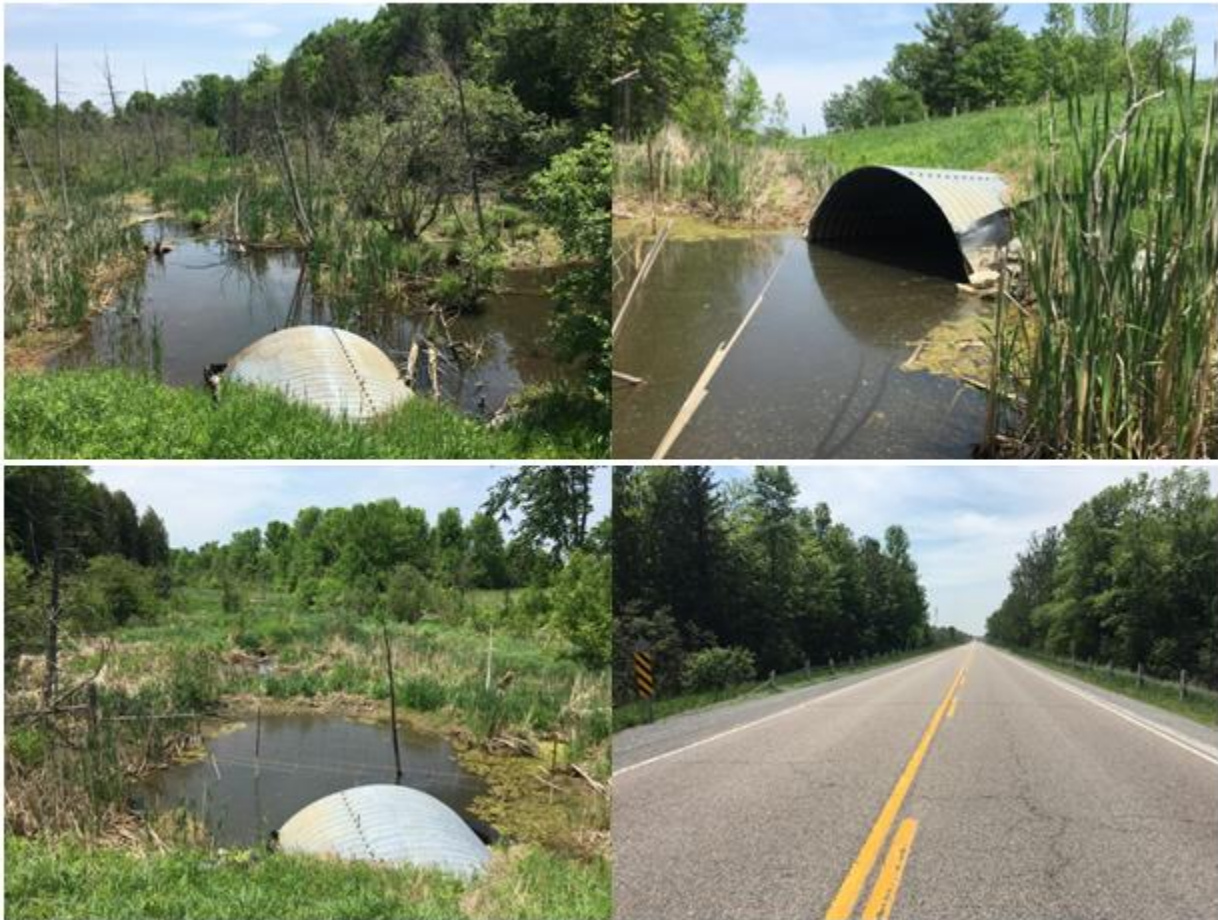
A tributary of the Talbot River flows under the road at this site. The crossing infrastructure consists of a CSP measuring 2.92 m in diameter and approximately 32.9 m in length (openness ratio of 0.2).

Figure 4. Photos of Site 3, clockwise from top left: view of culvert and wetland south of site; culvert, looking northwest; culvert and wetland on north side; view of road, looking west

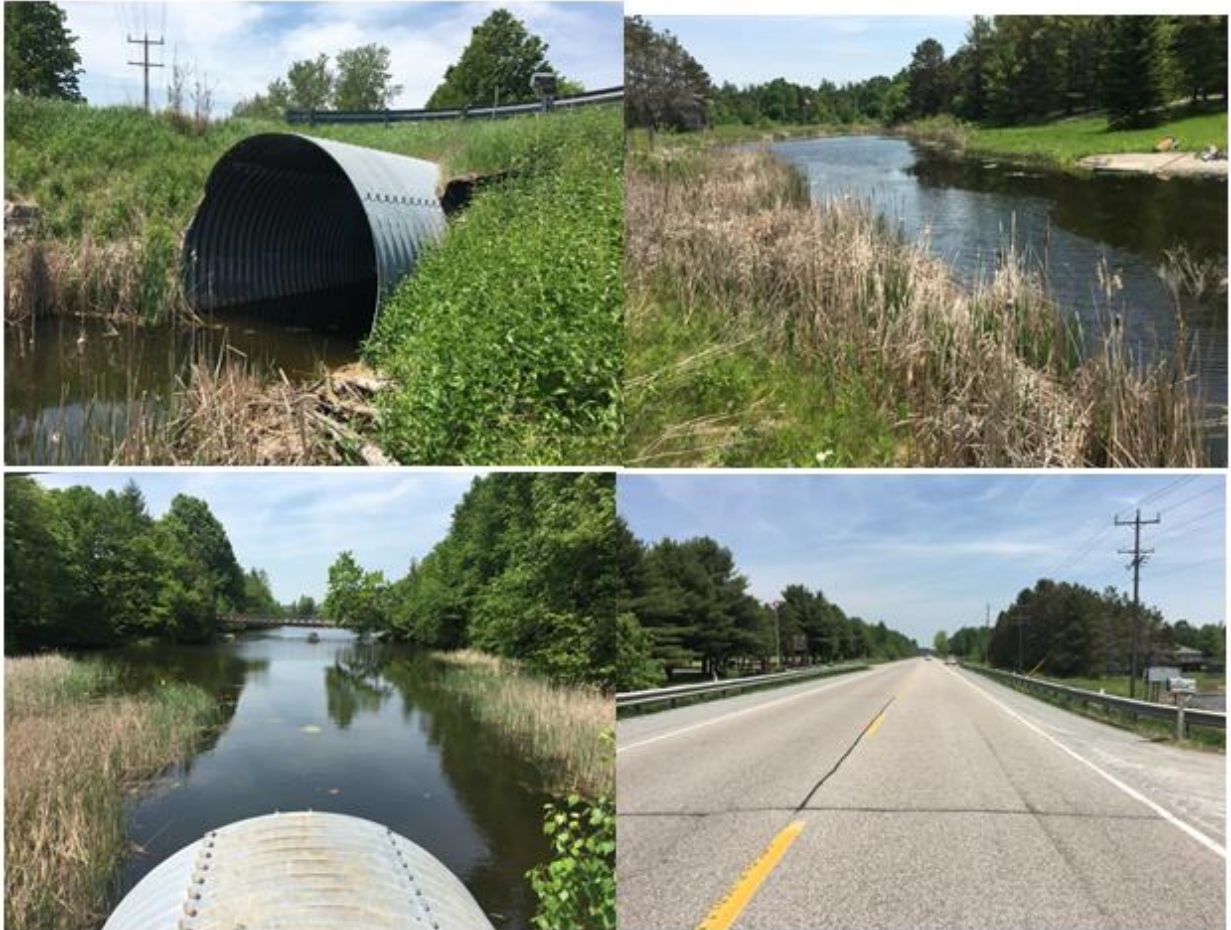
A tributary of the Talbot River flows under the road at this site. The crossing infrastructure consists of a CSP with a diameter of 2.95 m and a length of 31.5 m (openness ratio of 0.21).

Figure 5. Photos of Site 4, clockwise from top left: view of culvert, looking northwest; open water and cultural thicket, looking southeast; open water (Talbot River), looking north; view of road, looking east

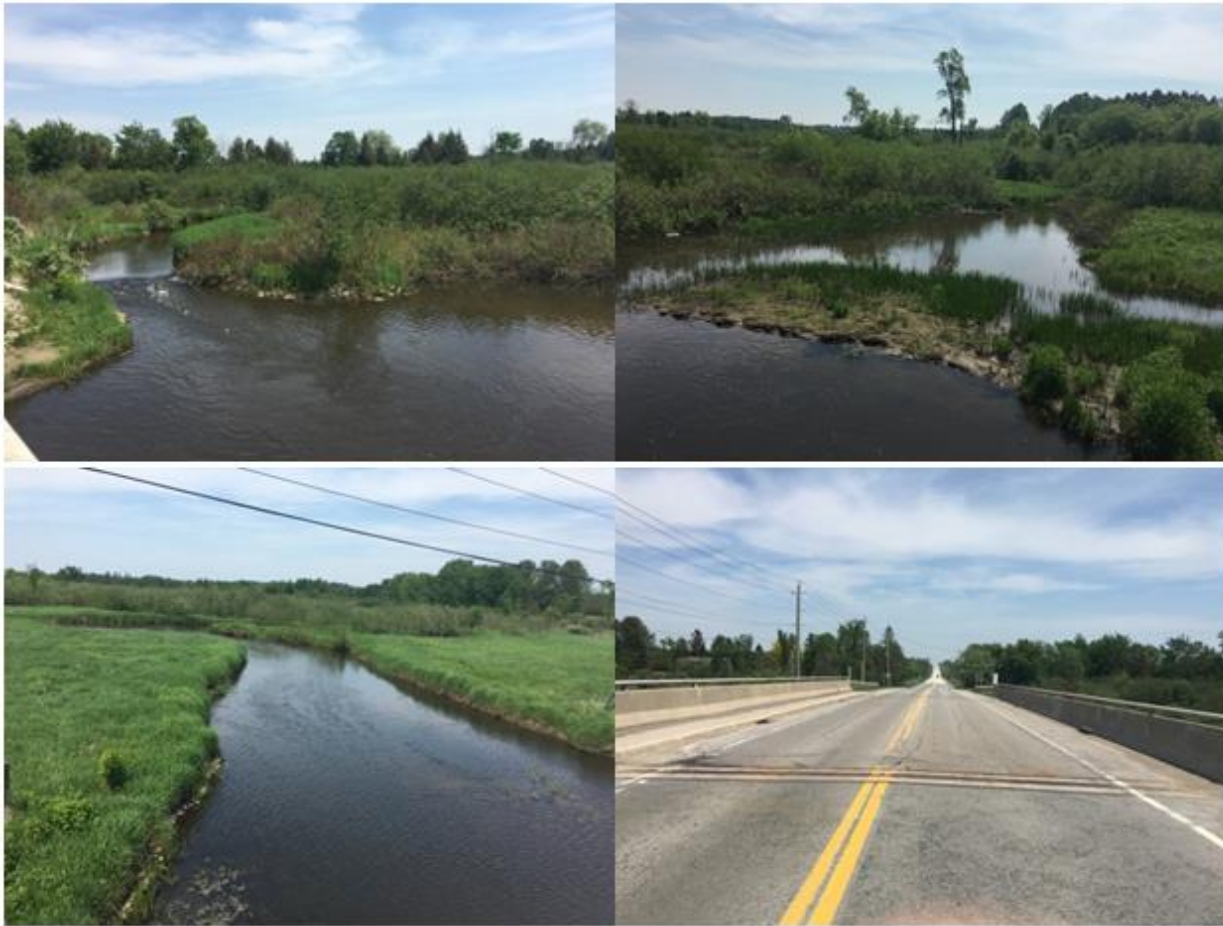
The Black River flows under the road through a bridge with an opening approximately 4.25 m high and 30.95 m wide, and a road width of 12 m (openness ratio of 11).

Figure 5. Photos of Site 5, clockwise from top left: view of thicket swamp, looking southeast; thicket swamp, looking southwest; shallow marsh, looking north; view of road, looking east

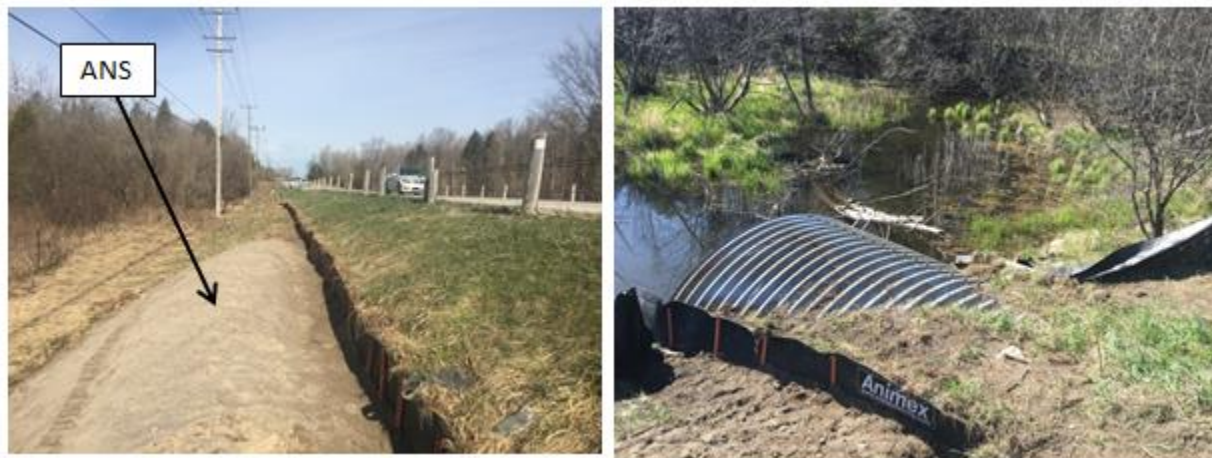
In April 2016, the ecopassages were installed at the five treatment sites. The ecopassages consist of Animex wildlife exclusion fencing installed alongside the roadway and attached to existing crossing infrastructure (culverts and bridges). The fencing is 41 cm high with a 10 cm angled lip at the top to prevent animals from climbing over. In order to meet the conditions of the LSRCA permit, the fencing was dug into the slope so that the top is even with the grade. With this design, the fencing does not interfere with road drainage, snow removal, or driver sight lines.

The fencing extends past the road crossing infrastructure on either side and runs parallel along the roadside, extending through wetland habitat and into adjacent forest habitat. At each end, the fence turns back on itself to orient turtles back towards the crossing infrastructure. Fence length at each site was determined based on the site characteristics and extended past the wetland habitat into adjacent natural features (e.g. forest). Images of the ecopassages and fencing are shown in Figure 6.

In order to provide safe nesting areas for female turtles, artificial nesting structures (ANSs) were installed at each of the ecopassage sites. The ANSs consist of a base layer of pea gravel overlain with brick sand, and were dug into the south-facing slope to maximize sun exposure and drainage. One to three ANSs were installed at each treatment site, depending on space availability. An image of an ANS is also shown in Figure 6. The lengths of fencing at each site are listed in Table 2, as well as the approximate cost of materials to create the ecopassages (fencing and ANSs).

Figure 6. Ecopassage fence installation showing the below-grade design and artificial nesting structure (left), and the connection to existing road crossing infrastructure (right).

Additionally, the initial fencing used was 41 cm high with a 10 cm angled lip at the top. This fencing proved effective at reducing turtle access to the roadway, but was not tall enough for some snakes and amphibians. It is recommended that in future projects, taller fencing should be used, where feasible, to exclude as many species as possible from the roadway.

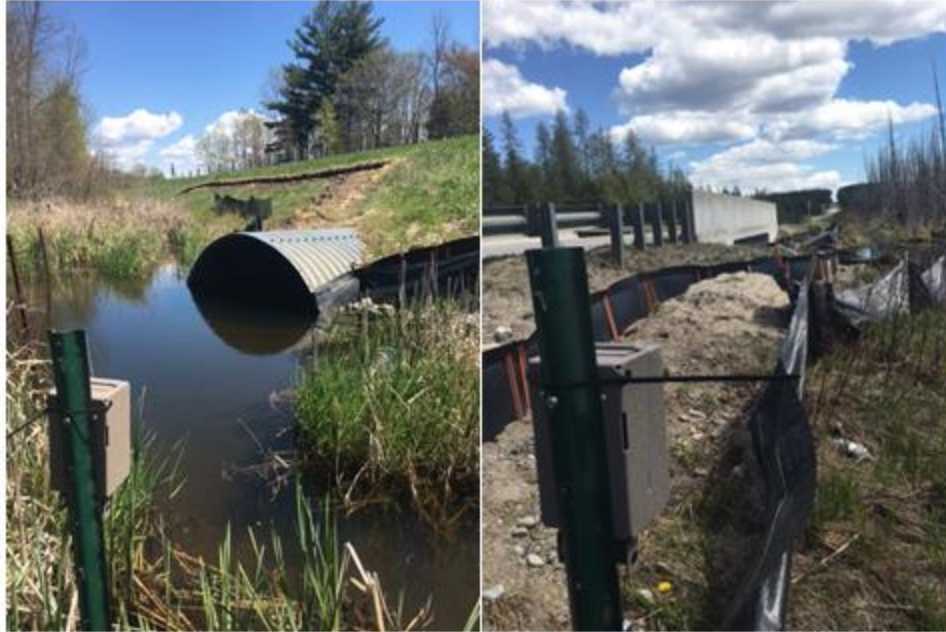
The use of the ecopassages and ANSs was monitored through the use of wildlife cameras. Cuddeback Long Range IR trail cameras were installed onto U-posts facing either the culvert or the ANS (Figure 3). The cameras were set with the time-lapse function and took a photo every minute continuously during the monitoring period. The photos were then uploaded onto a computer and manually checked for evidence of wildlife using the ecopassages or ANSs. Due to timing and personnel constraints, only 55% of these photos (a randomized subsection) were manually checked by LSRCA staff and volunteers for the presence of turtles and other wildlife. These results were then extrapolated out to the entire data set to estimate total wildlife occurrences. Where possible, the species as well as their behaviour was identified.

Figure 7. Trail cameras set to capture wildlife passing through the ecopassages (left) and using the artificial nesting structures (right)

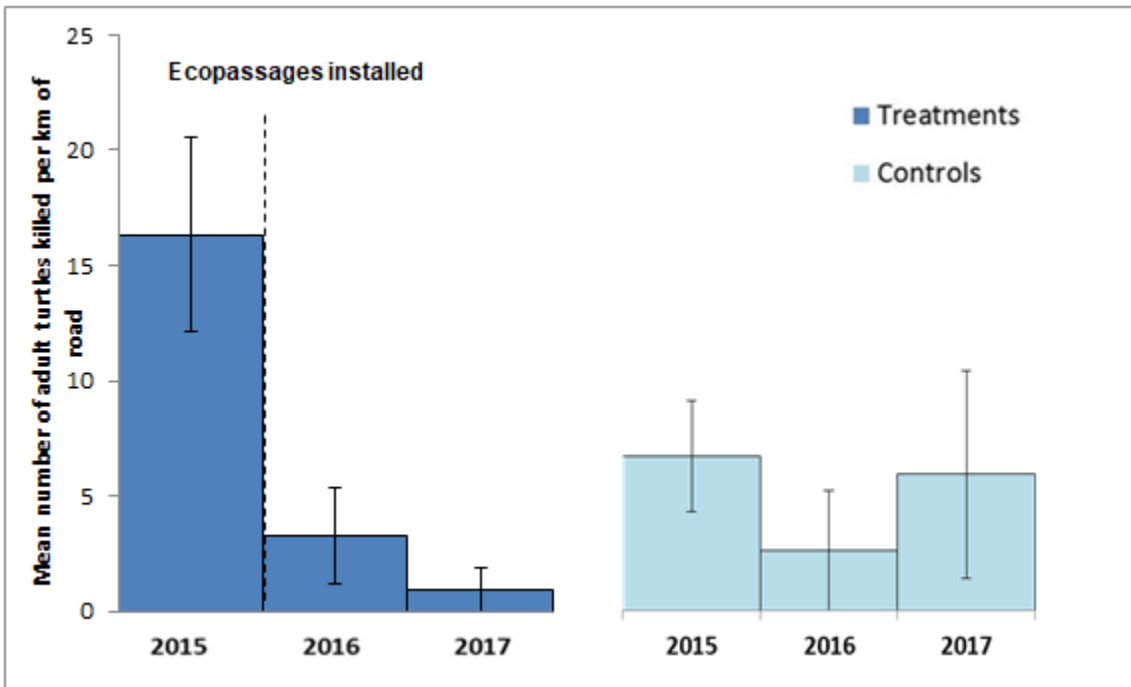
Figure 9. The mean number of adult turtles killed per km of road at treatment and control sites from 2015-2017. The ecopassages were installed in early 2016, so 2015 represents pre-fencing data and 2016/2017 represent post-fencing data. Error bars represent the standard error of the mean.

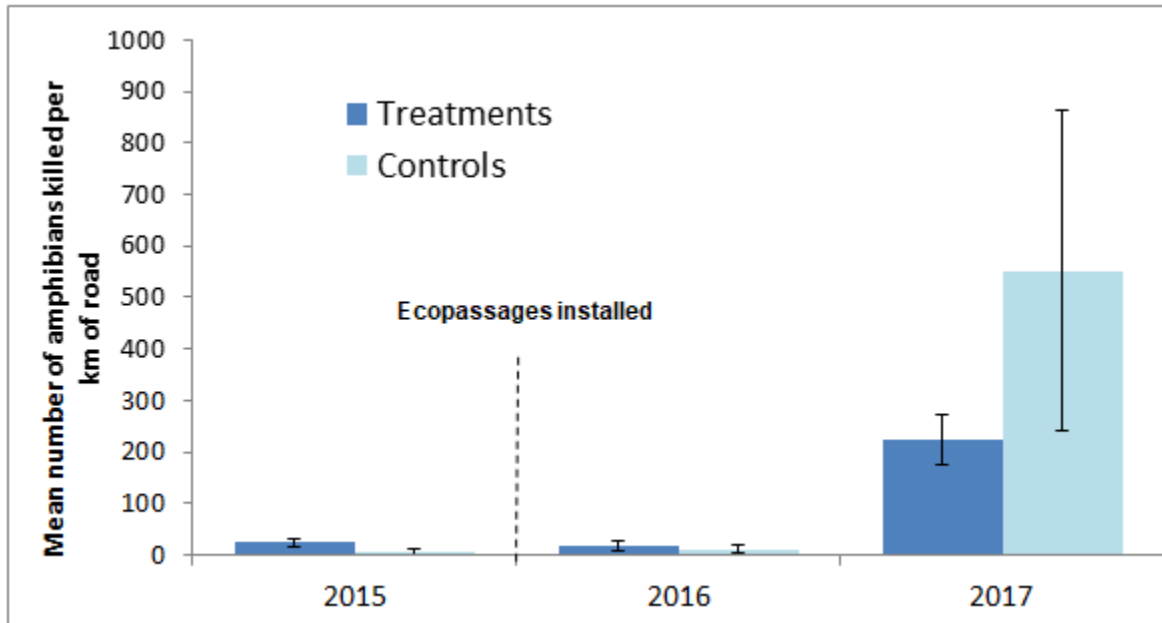
Figure 10. The mean number of amphibians killed per km of road at treatment and control sites from 2015-2017. The ecopassages were installed in early 2016, so 2015 represents pre-fencing data and 2016/2017 represent post-fencing data. Error bars represent the standard error of the mean.

Looking at other non-target species, road mortality of amphibians and snakes at all sites (treatment and control) remained relatively unchanged between 2015 (before ecopassage installation) and 2016 (after ecopassage installation). However, there was a significant increase in road mortality at all sites in 2017 (second year after ecopassage installation) (Figure 10 and 11). This increase was more pronounced at the control sites for amphibians, and at the treatment sites for snakes.

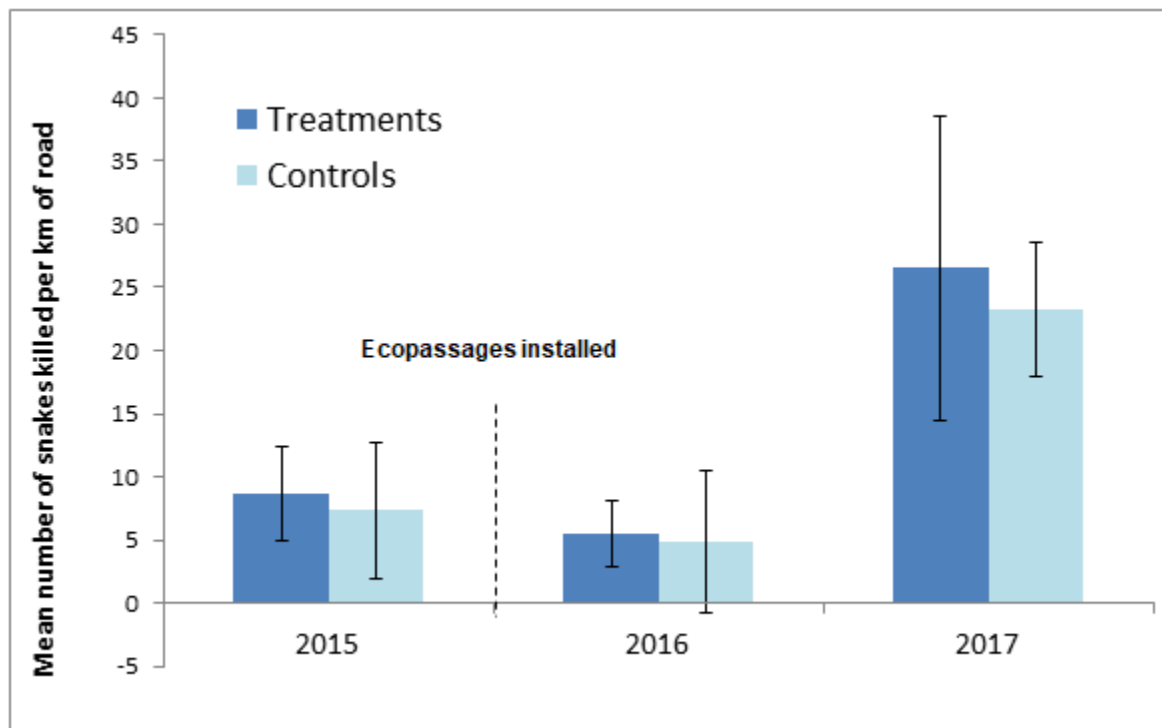
Figure 11. The mean number of snakes killed per km of road at treatment and control sites from 2015-2017. The ecopassages were installed in early 2016, so 2015 represents pre-fencing data and 2016/2017 represent post-fencing data. Error bars represent the standard error of the mean.

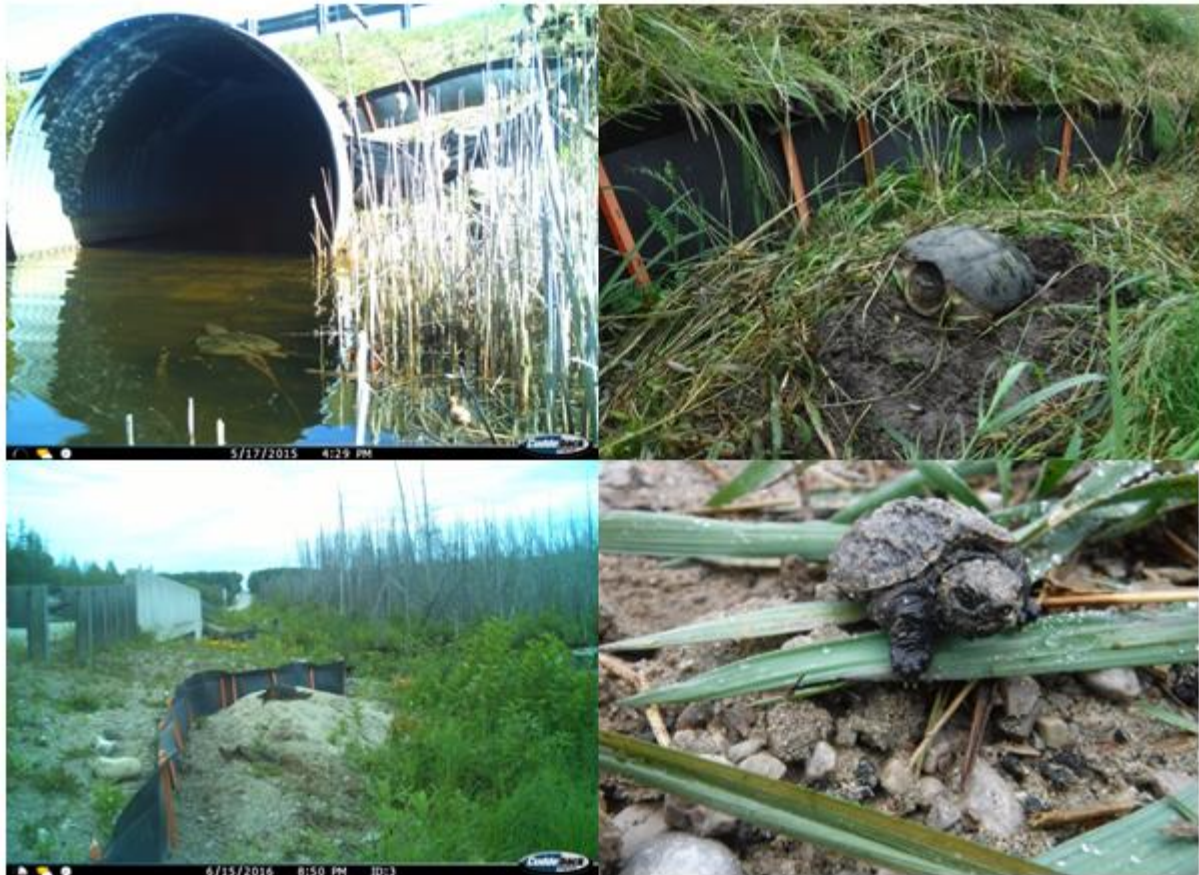
Over 1.7 million photos were recorded over 1400 days (all cameras combined). Over the study period, there were an estimated 200 occurrences of turtles crossing through the ecopassages and 18 turtles were actually observed using the ANSs. It is important to note that some of these occurrences could represent the same individuals at different times. A summary of the trail camera data is shown in Table 6. Some example photos of turtles observed during the study period are shown in Figure 14.

Figure 14. Snapping turtles observed at the sites during the project, clockwise from top left: crossing through an ecopassage, nesting beside the exclusion fencing, two females using an ANS, a hatchling emerging from a nest
