2013

Showcasing Water Innovation: Stormwater Performance Monitoring Report

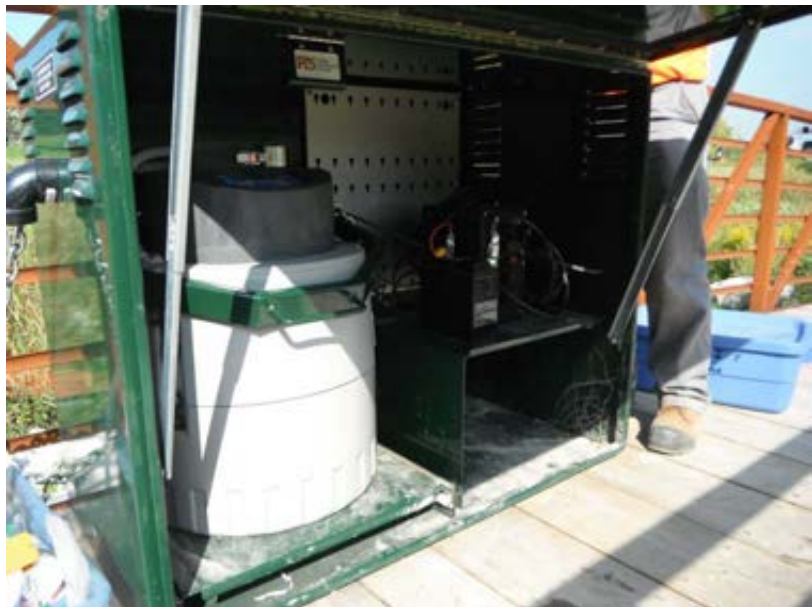
Figure 1 - Monitoring equipment setup at Colony Trail facility

Autosamples were used to collect water samples during storm events. Samples were combined to represent the rising limb, peak and falling limb of the event hydrograph if sufficient sample water was available. The samples were analyzed for total

phosphorus (TP), orthophosphate, chloride (Cl⁻), and total suspended solids (TSS) for each event captured. The resulting concentrations when combined with the water balance yield a mass balance for each parameter for each captured event. The reduction of a given parameter at the outlet, compared to the inlet, was considered the efficiency of the facility for that event.

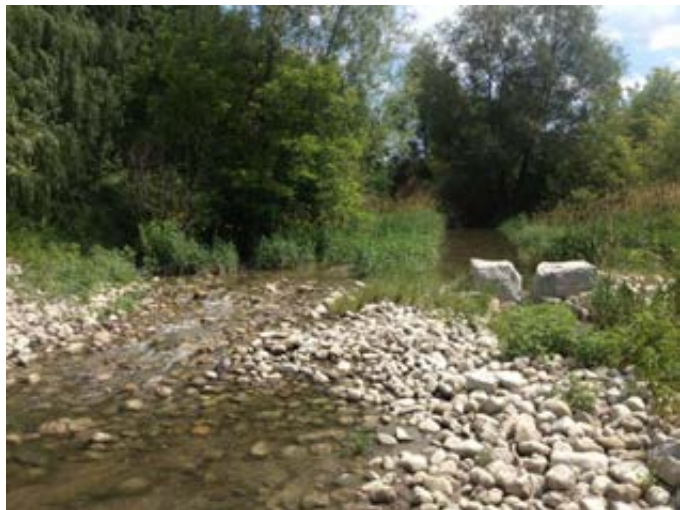
Figure 2 - Inlet Channel to George Richardson Pond showing stone flow splitter and By-pass Channel on right

As the project was a retrofit there was a number of existing site constraints that had to be accommodated. This included a flow splitter to a permanently flowing by-pass channel to accommodate fish passage around the online facility, and minimal change to the grade of the facility as it lies in the flood plain.

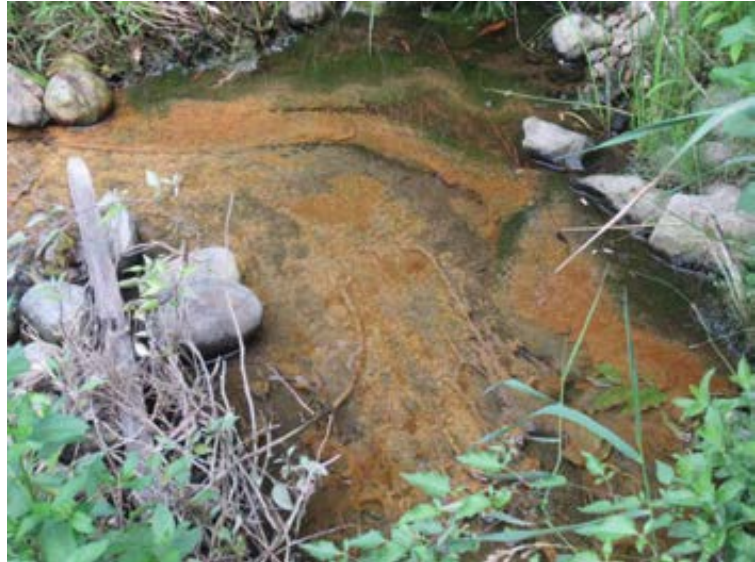
Figure 1 - *Leptothrix ochracea* bloom at red sand filter outlet in late July

Interestingly in late July, 2013 a rust

coloured bloom was observed in the outflow water of the red sand filter. This was identified as *Leptothrix ochracea*, a species of iron-loving bacteria that also prefer low oxygen conditions. While water quality samples did not detect dissolved iron the presence of this bacteria would suggest that the bottom draw is introducing hypoxic waters into the filter from the pond. With the filter being iron rich this is also the likely source of the bloom. Continued blooms such as this one raise the question of the longevity of the filter. In addition the iron / orthophosphate bond that makes the filter effective at phosphorus removal is broken in low oxygen conditions.

Poor OP removal is most obvious during a in a few events in mid-summer. The iron / phosphorus bond that facilitates the removal of OP in the red sand filter can be broken under hypoxic or anoxic conditions. With the water that is directed through the filter coming from a bottom draw in the pond it is very likely that the filter will periodically receive hypoxic / anoxic water. This is particularly likely during dry, hot spells in summer that would promote stratification in the pond (or from chemical stratification in the form of chloride as discussed below). As such it is suspected that the poor OP removal of the July 5th, July 23rd, and August 1st events are a result of hypoxic / anoxic water moving through the filter. That low oxygen conditions occurred at this time is further supported by bloom of *Leptothrix ochracea* observed in late July and August as these bacteria prefer low oxygen conditions.

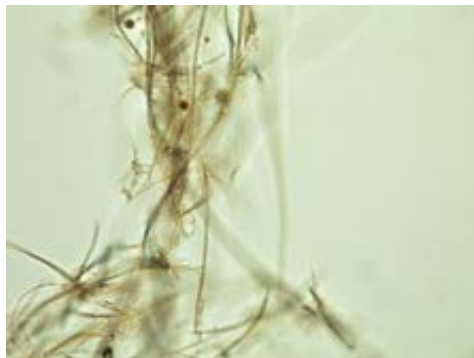
Figure 4 - 400x magnification of *Leptothrix ochracea*

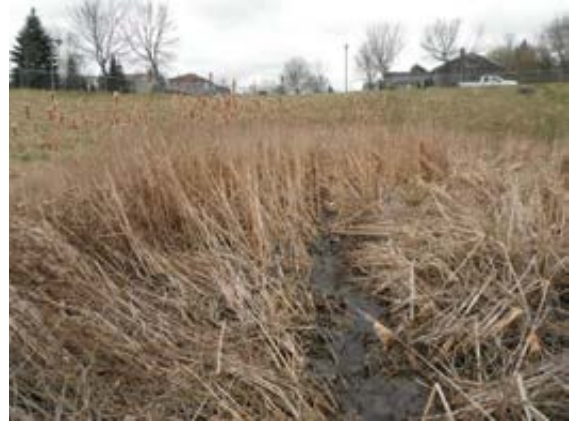
Figure 5 -Prior to the retrofit the facility consisted primarily of a grassed waterway

Monitoring was conducted on the Colony Trail facility from May through to mid-September of 2012 in order to capture pre-construction performance of the facility. The facility consisted primarily of a grassed channel between the outfall and receiving water course with minimal water retention occurring. It was decided that monitoring would be conducted only at one location (outlet) as there would be no discernable difference in water volume or quality between the storm sewer outfall and the facility outlet. Typically the facility was found to respond to storm events very quickly with the rise to peak on the event hydrograph occurring within 5 to 10 minutes.

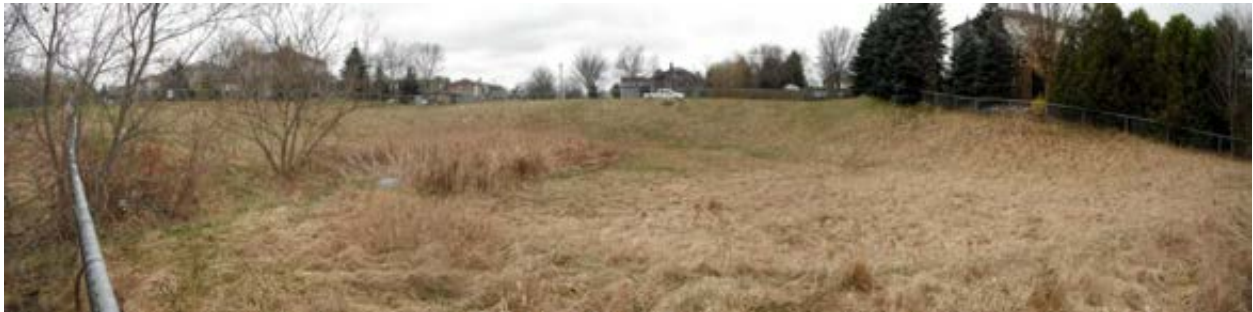
Figure 6 - Overview of pre-construction facility

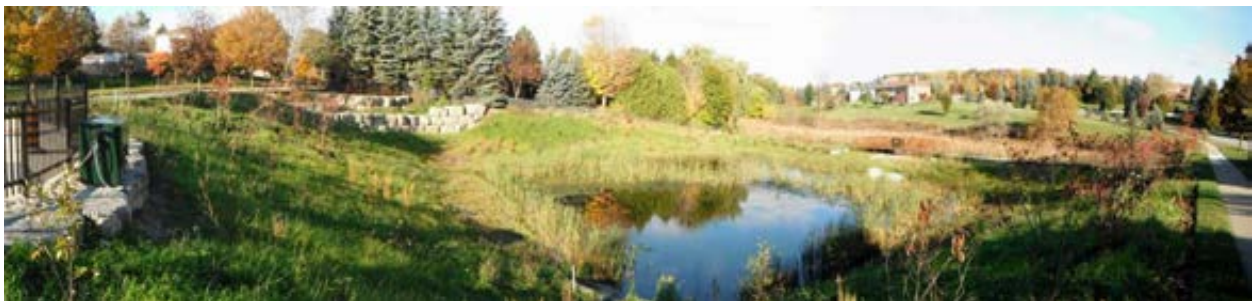
Figure 7 - Overview of post-construction facility

Construction on the facility was not complete until late September, 2013 leaving little time for adequate monitoring to be conducted before winter. As such, monitoring commenced mid-September and ran until mid-November capturing 6 events, 4 of which were of sufficient volume to be used for performance evaluation of the facility. Water quality and quantity were captured at the storm sewer outfall to the facility (inlet) as well as at the outlet. Monitoring at the outlet was set below the Sorbtive media chamber meaning water quality improvements would be a combination of water moving through the wetland and Sorbtive media chamber. Results are displayed below in Table 5.

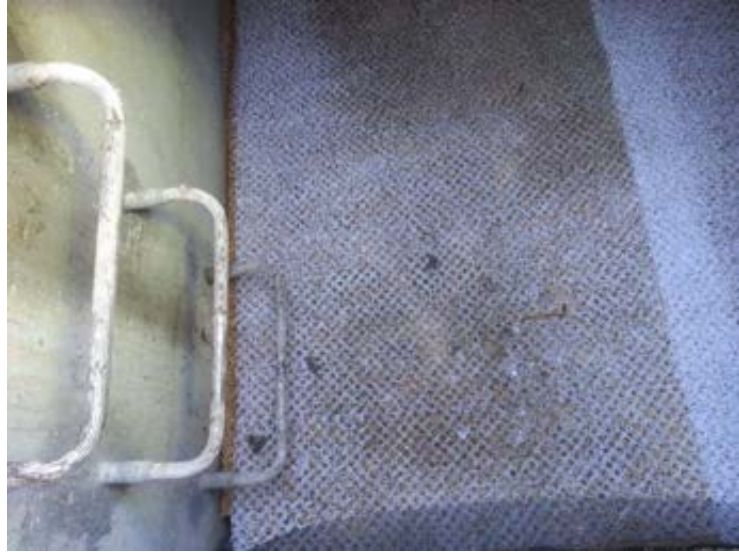
Figure 8 - View inside Sorbtive media chamber, media overlain with permeable layer to hold the Sorbtive media in place

The Imbrium Sorbtive media chamber installed at this facility is designed to remove dissolved (ortho)phosphate. Ironically, with this facility receiving atypically high orthophosphate loads it turned out to be an ideal location to test the Sorbtive media. For the four events that were captured, OP made up approximately 50% to 75% of the TP load. It is somewhat atypical to have such a large proportion of the TP load comprised of OP as this is a very reactive and bioavailable form of phosphorus. For all inlet sample concentrations, the proportion of TP that was comprised of OP was on average 60%. Encouragingly, OP (and therefore TP) reductions were good (mean = 66%) considering the proportions entering the facility. Typically, high reductions in phosphorus will be a result of high total suspended solids (TSS) removal as these particles act as a transport mechanism for phosphorus. Given that TSS reductions were moderate to poor but good phosphorus reductions were still achieved suggests a high removal efficiency achieved by the Sorbtive media. This is particularly evident in the September 21st event where no TSS reduction was achieved, poor TP reduction was achieved, but 50% of OP was still removed.

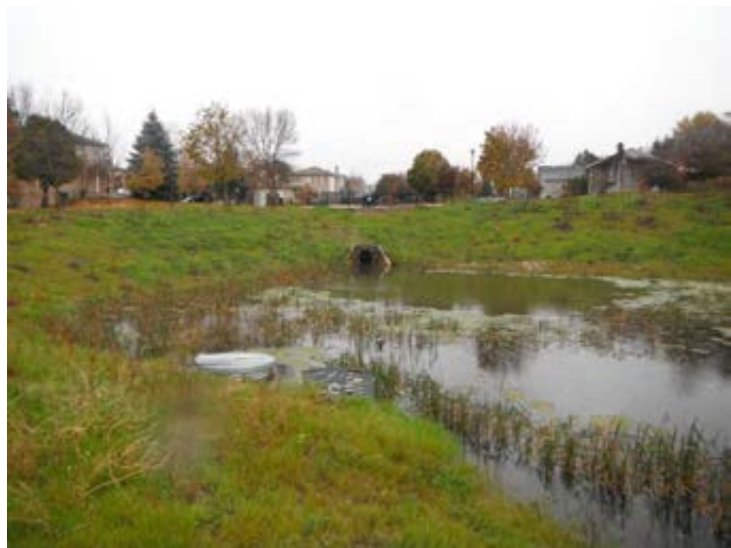
Figure 9 - Colony Trail wetland, outlet structured in foreground, inlet structure in background

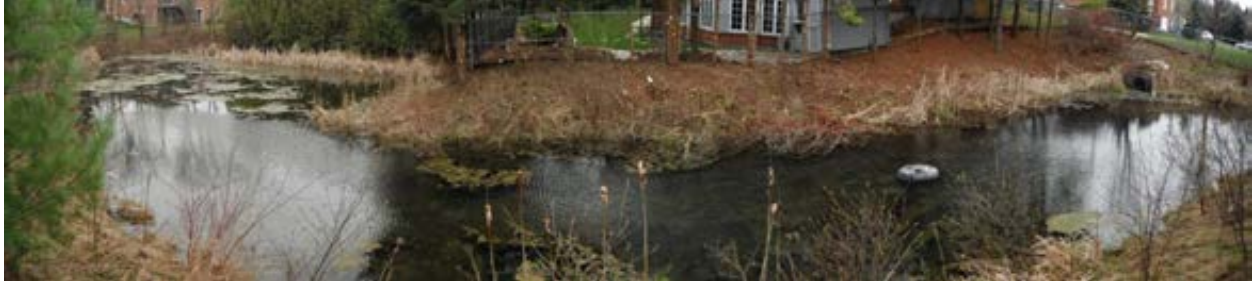
Figure 10 - Overview of facility pre-construction

Pre-construction monitoring was conducted on Lincoln Pond from early May through to early August 2012. Post-construction monitoring was conducted from early May through to the end of October 2013. Sample results for both years can be seen in Appendix A.

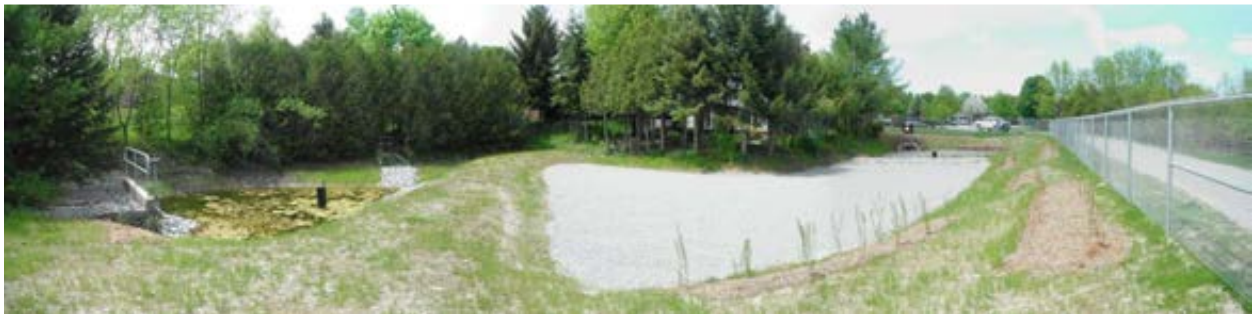
Figure 11 - Overview of facility post-construction

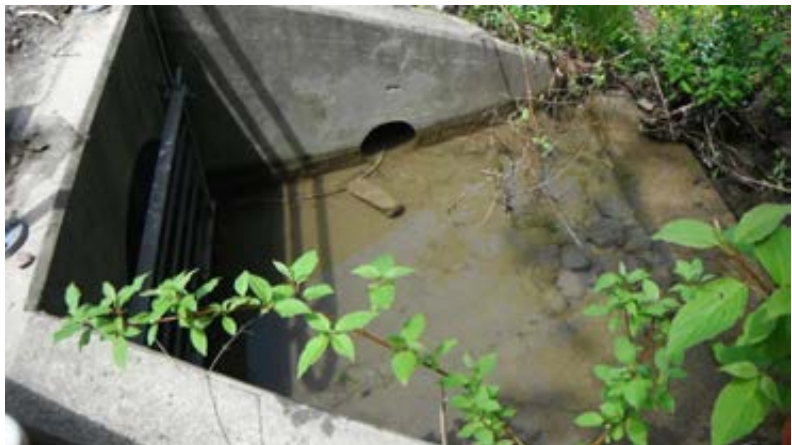
Figure 12 - Joint outlet of King St stormsewer and Lincoln facility under low flow conditions. Lincoln outlet is the small diameter pipe on right wing wall

The outlet of the facility, which remained unchanged through the retrofit, shares a headwall structure with the uncontrolled King St catchment directly to the south. As part of the project a Wilkinson Box Oil-Grit Separator was installed to give some treatment to runoff from the King St catchment. On May 28 2013 the Wilkinson-Box became clogged leading to a surcharge flow eroding much of the bank around the shared outlet headwall. Remediation of the erosion required the placement of a silt fence downstream of the headwall in the outlet channel which remained in place until late July. The placement of the silt fence served to highlight the tendency of the faster responding, larger King St catchment to backwater into the Lincoln facility.

When the valve is open there is a 20 cm fall to the headwall that is shared with the King St storm outlet (Figure 12). The smaller diameter Lincoln outlet is always partially full (at approximately 8 cm water depth) due to the toe configuration of the headwall

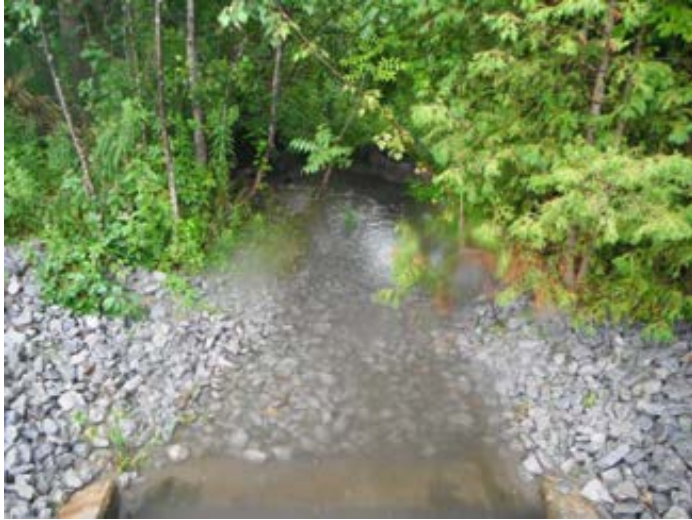
Figure 13 - Lincoln and King St outlet under high flow conditions. Water depth exceeding 20 cm.

structure. During storm events the larger, faster responding King St stormwater flows inundate the Lincoln outlet (Figure 13) and for the periods where the water depth exceeds 20 cm the King St stormwater can backwater into the final wet cell of the Lincoln Facility through the open maintenance valve.

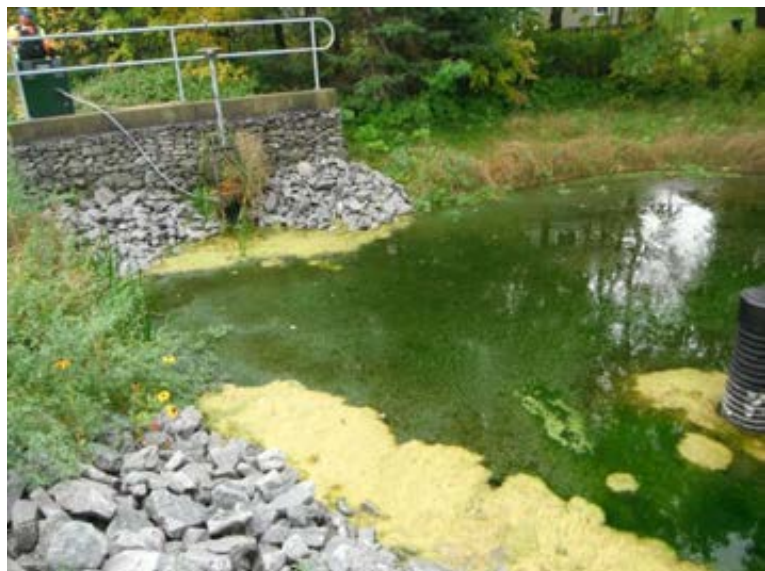
Figure 14 - Plant and Algae growth in final wet cell, September 2013

The effect of the backwatering was also evidenced by the increasing proliferation of plants and algae observed in the final wet cell as the summer and fall progressed (Figure 14) Based on visual inspections, the growth in the final wet cell was seen to equal, if not exceed, that of the preliminary wet cell.

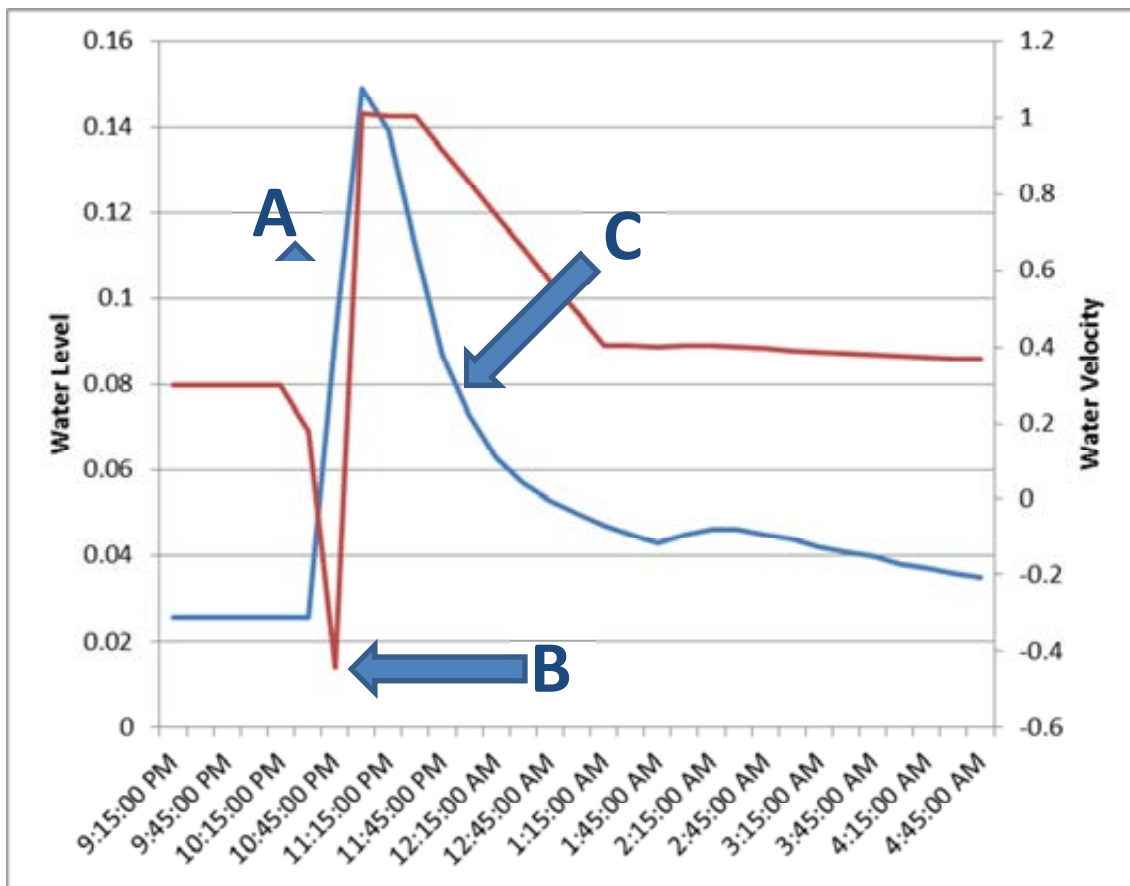
Figure 15 – Hydrograph of backflow event in final wet cell at Lincoln Facility

The effect of this backwatering can be seen in the event captured on August 6 2013. The results (Figure 15) show a small but intense precipitation event at the Lincoln outlet. The velocity (in red) shows an initial backflow as the water levels in the uncontrolled King St catchment rise faster than stormwater flowing through the Lincoln facility. The water quality sample captured prior to backflow (A) (Table 8) shows the ambient water quality in the wet cell prior to a storm water input. Sample B highlights the poorer water quality associated with uncontrolled King St stormwater backwatering into the wet cell, particularly total suspended solids. The water quality captured by Sample C is a result of uncontrolled stormwater mixing in the final wet cell with stormwater that has moved through the engineered wetland. As a result, none of these samples would be considered representative of stormwater that has been treated

through the wetland facility. Indeed, due to repeated backwatering and mixing of stormwater into the final cell of the Lincoln facility, it was not possible to capture any samples that were considered to be uninfluenced by uncontrolled King St stormwater. Therefore, evaluation of the effectiveness of the facility could not be conducted as the facility itself was not functioning as designed.
