# Lake Simcoe Shoreline Hazard Mapping

## Final Report

April 4, 2024 | 13671.101.R1.Rev2

Lake Simcoe Region Conservation Authority  
120 Bayview Pkwy, Newmarket, ON L3Y 3W3

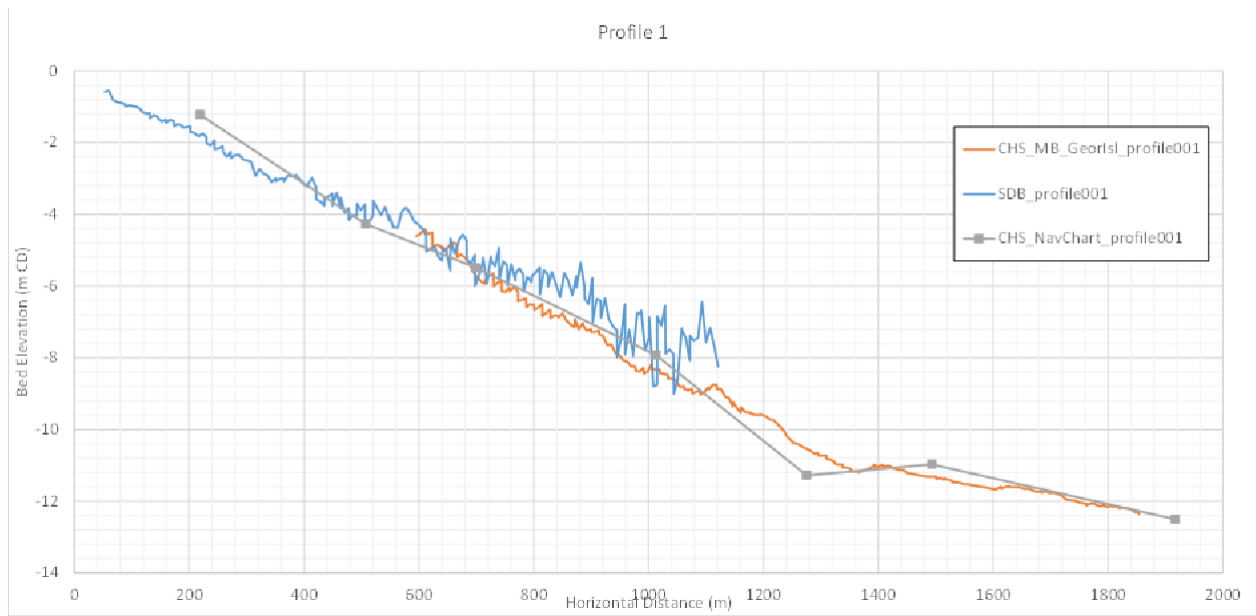
**Figure 2.11: Comparison of CHS Multi-beam, CHS Point Data and SDB Bathymetric Data at Profile 1**

Cross sections were cut through regions where there was intersection of the CHS multi-beam data and the SDB. In most locations, the availability of the two data sets were more complimentary than redundant, with only small regions of duplicate coverage. An example cross section with the bathymetry data sets is shown in Figure 2.11. Further comparisons of the bathymetric data and the profile locations are provided in Appendix A. These plots show generally good agreement between the SDB, the older CHS data and the newer multibeam CHS data.

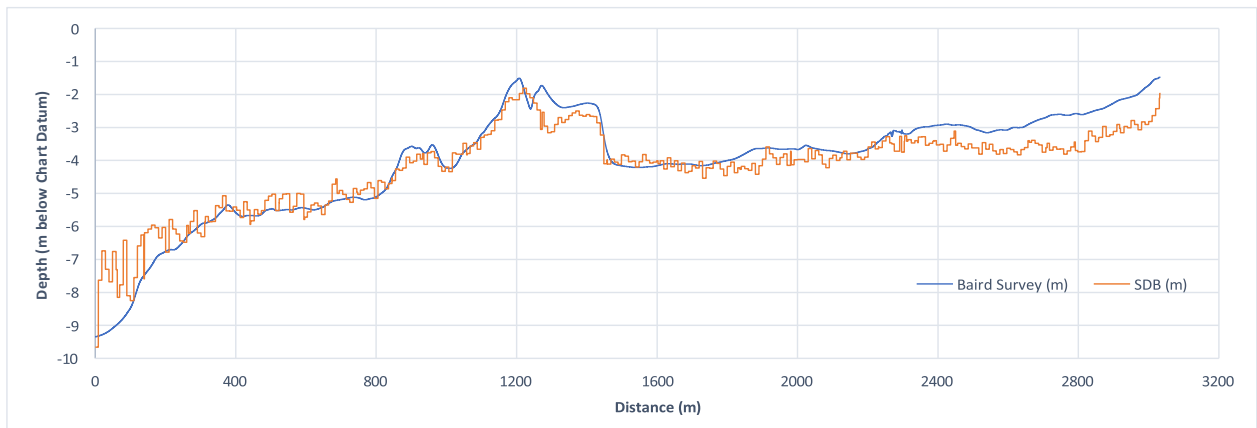
**Figure 2.13: Comparison of SDB and Verification Boat Survey Data Measured in September 2022**

The general conclusion from these surveys was that the SDB provided a good representation of the bathymetric depths; however, there was some variability that seemed to be somewhat regional. Deeper water depths were often under-reported in the SDB (reported as shallower than they were), while in shallow regions the SDB tended to report deeper water depths. This can be seen in the comparison in Figure 2.13 for profile SB\_000\_1310.

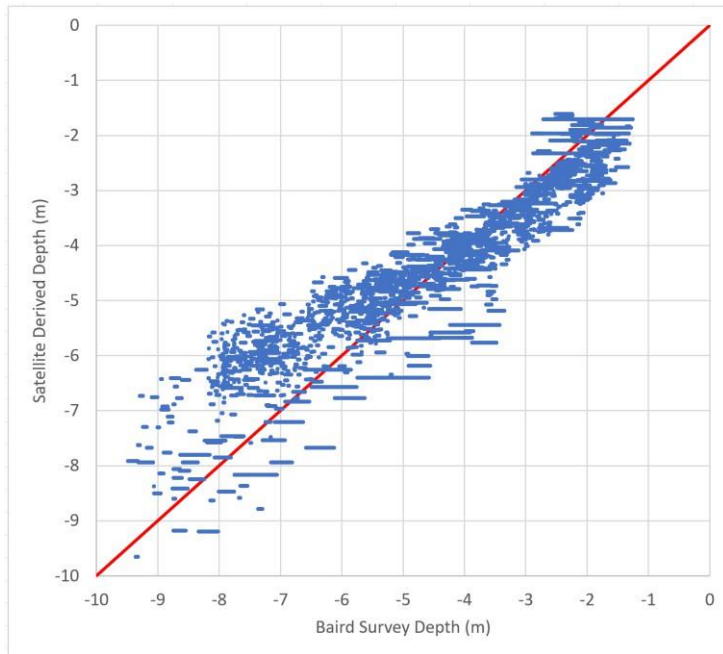
**Figure 2.14: Depth versus Depth Plot for SDB and Boat Survey**

The differences in the data are also demonstrated through a comparison of Baird's boat-measured survey points (Sept 8, 2022) and the SDB extracted at the same location (Figure 2.14). With perfect agreement of the two data sets, all of the points would plot along the red 1:1 line. In terms of predicting wave heights, the deviation from the 1:1 line in shallower water with the SDB reporting slightly deeper depths will be conservative, as a model with deeper water depths could allow slightly larger waves to reach the shoreline. The deviation from the 1:1 line in the 6 to 7 m water depth is of little consequence to the processes that reach the shoreline, as these depths are located a significant distance offshore.

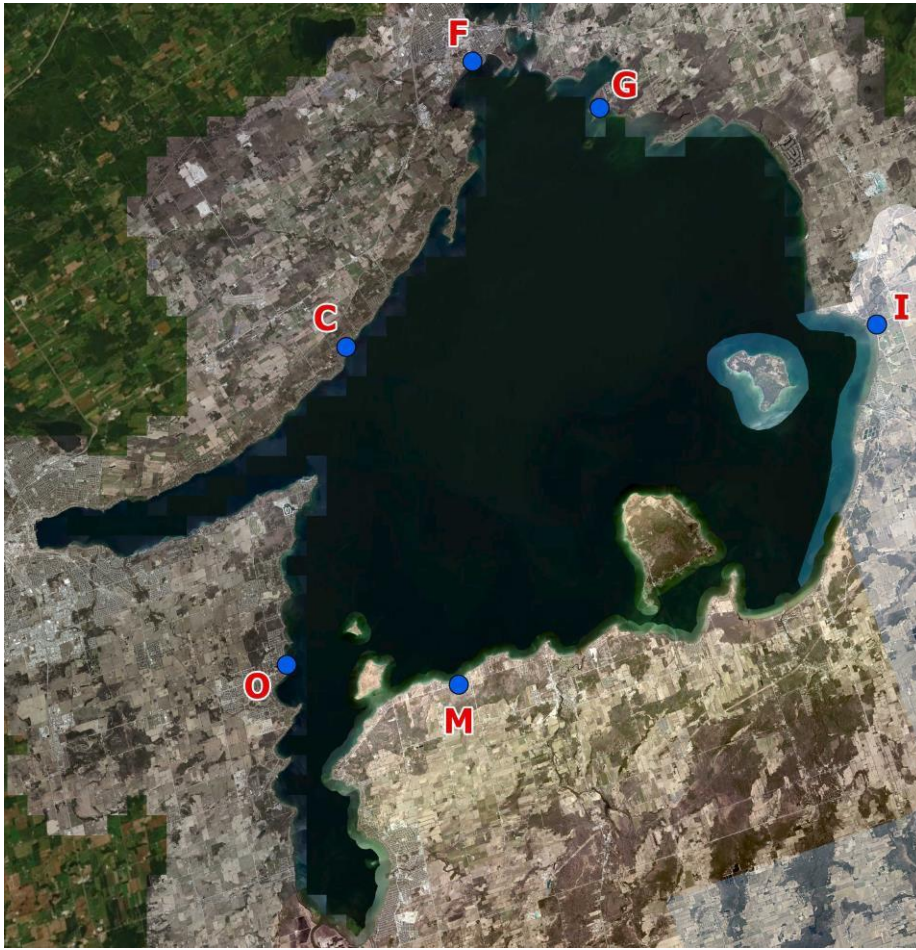
**Figure 2.16: Selected Locations for Shoreline Recession Assessment**

(Figure 2.16) were typically park areas, or areas where farming had continued until recently and no development had occurred along the shoreline.

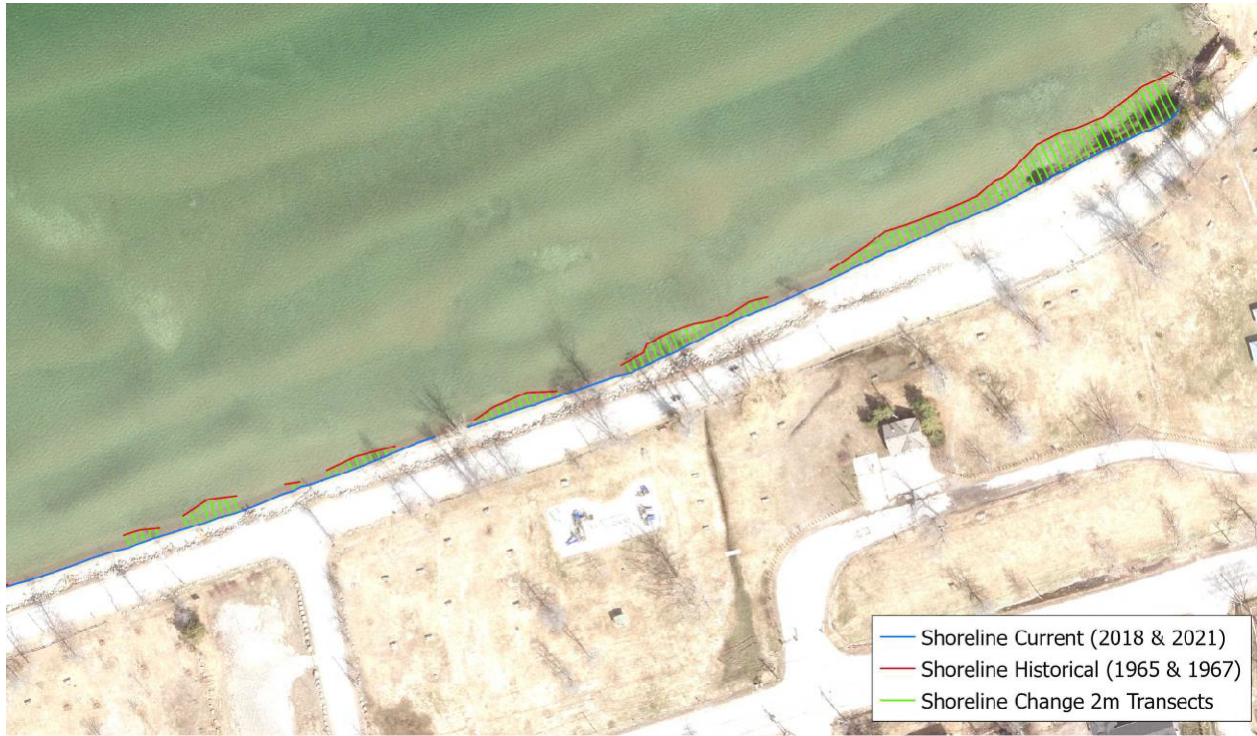
**Figure 2.17: Recent Aerial Photograph and Historical Shorelines Showing Shoreline Change**

Historical aerial images that covered the area of interest were obtained from the National Air Photo Library. The historical imagery were from 1965 and 1967. Recent aerial images from 2018 to 2021 were then compared, resulting in a time span of about 53 to 57 years at the selected sites. An example of the shoreline positions from historical and recent imagery at “Site M” is shown in Figure 2.17. The green lines represent the difference in the shoreline position along transects spaced at 2 m. At this site, the average rate of recession was determined to be about 0.09 m/yr.

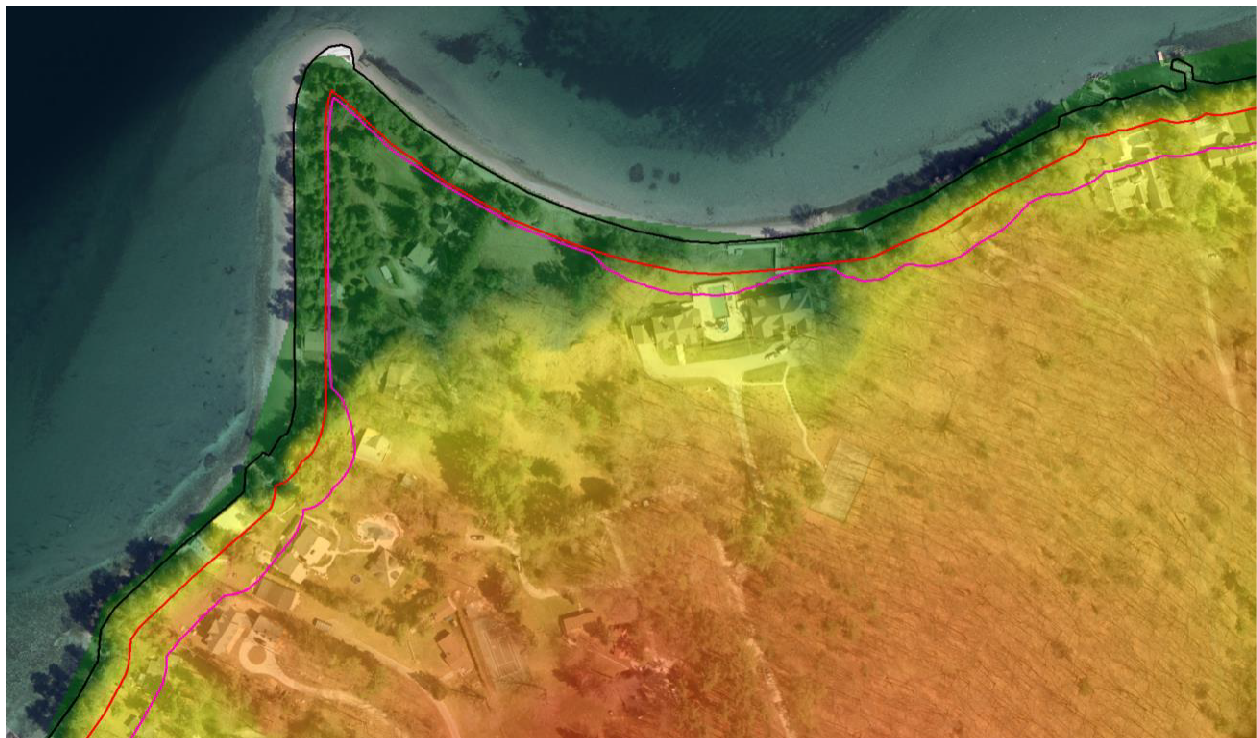
**Figure 7.2: Example of Stable Slope Allowance in Variable Topography**

An example of the product of this approach in a region with topographic variability is shown in Figure 7.2. In this figure the lower lying areas have minimal stable slope allowance (e.g., on the point with green colours), while the higher regions have an increased offset (e.g., in the yellow/orange colour).

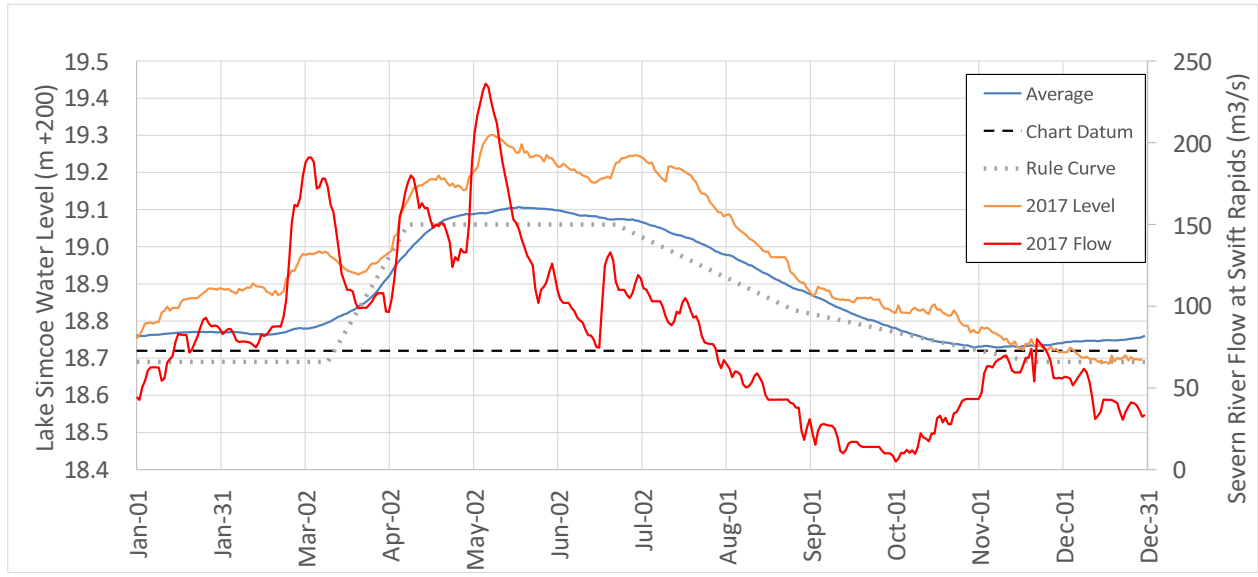
**Figure 8.1: Lake Simcoe Levels and Severn River Flows in 2017**

The period of 2017 through 2019 saw flooding in many parts of Eastern Ontario, including Lake Ontario and other large rivers such as the Ottawa River. Lake Simcoe did not appear to be unusually high during this period. Some of this may be attributed to the higher flows in the Severn River from late February to the middle of March in 2017 (Figure 8.1). This type of flow increase in a managed system is consistent with planning for the freshet and perhaps more aggressively lowering the lake in advance of a stronger freshet. The strong outflow in early March of 2017 lowered Lake Simcoe and probably mitigated what may have been a year with higher water levels.

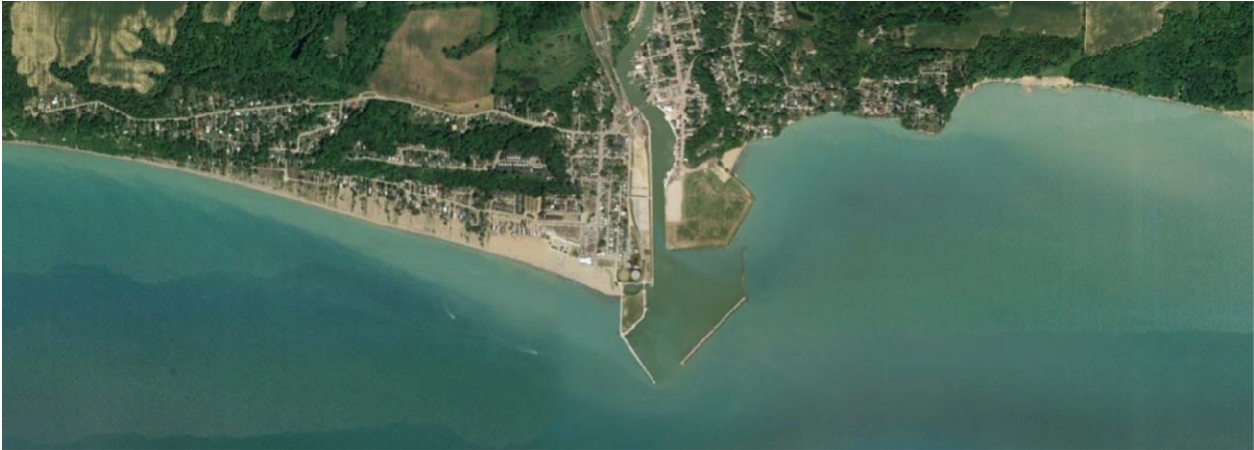
**Figure 9.2: Disturbance in Alongshore Sediment Transport at Port Stanley, Lake Erie**

Shore protection structures that protrude from the shore, such as groynes, often provide a clear indication of the direction and approximate magnitude of alongshore sediment transport. An example of this can be seen at Great Lakes locations such as Port Stanley, shown in Figure 9.2, where strong west to east sediment movement has been interrupted by coastal development. These types of disruptions are also created by natural headlands and can result in gradually accreting beaches over thousands of years.

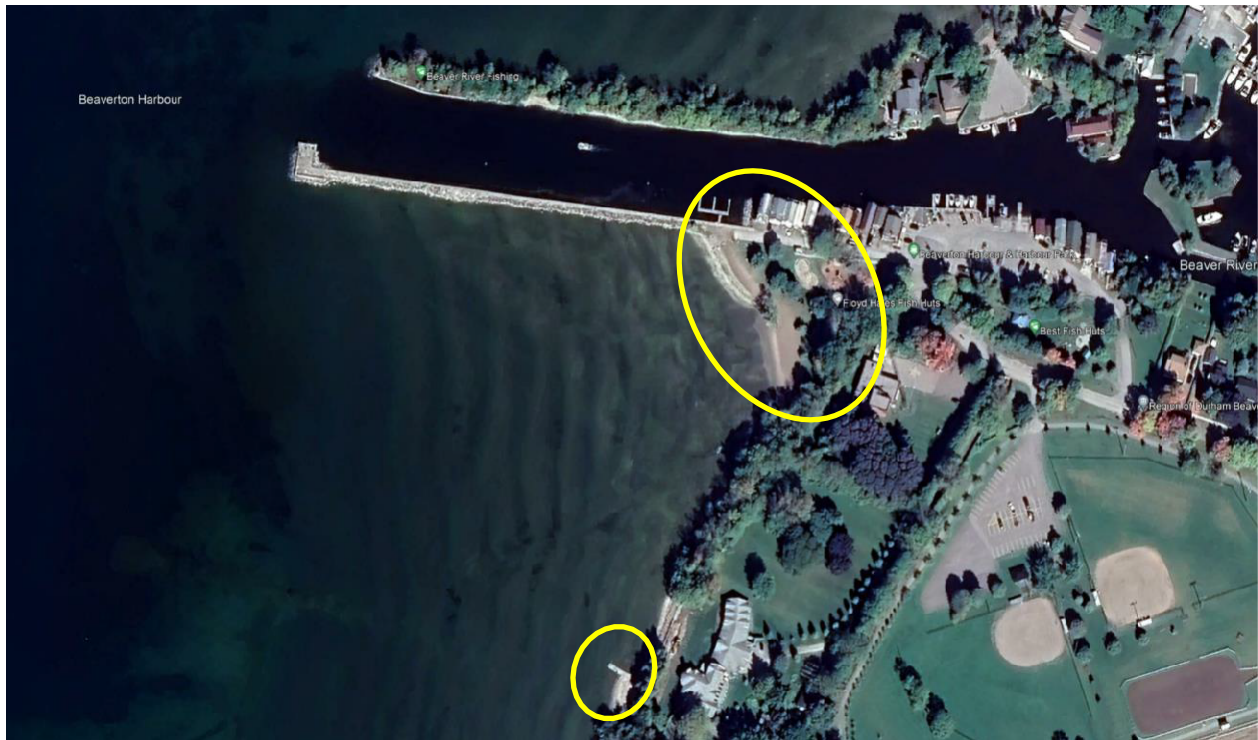
**Figure 9.3: Sediment Accumulation Adjacent to Beaverton Harbour**

The processes around Lake Simcoe are somewhat different, with limited evidence of large volumes of sediment accumulating adjacent to shore-perpendicular structures. There are some examples of moderate to smaller accumulation at locations such as Beaverton Harbour, where a sand fillet has developed on the south side of the harbour in response to southwesterly winds and waves (Figure 9.3). A smaller and less obvious sand accumulation also exists on the north side of the structure. A few smaller structures south of Beaverton Harbour also show similar patterns of sediment accumulation.

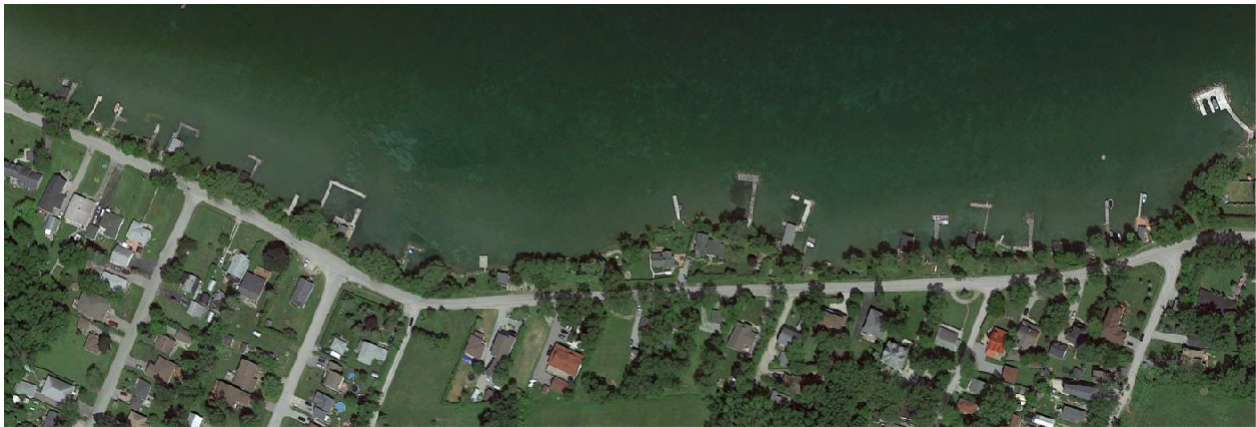
**Figure 9.4: Offshore Breakwaters Along Shore South of Snake Island**

There are many examples of offshore breakwaters on Lake Simcoe, with most of these being small structures that may be part of a dock or are just in front of a dock. Most of these structures are in regions that do not have sandy substrates and there has therefore been little if any accumulation of sediment in the lee of these structures. An example of this is in the region adjacent to Snake Island, as shown in Figure 9.4. This region does not have visible sand bar formations in the aerial imagery and appears to be a hard bottom. Consequently, the alignment of the shoreline appears mostly unaltered and even very enclosed basins appear to be clear of sediment accumulation.

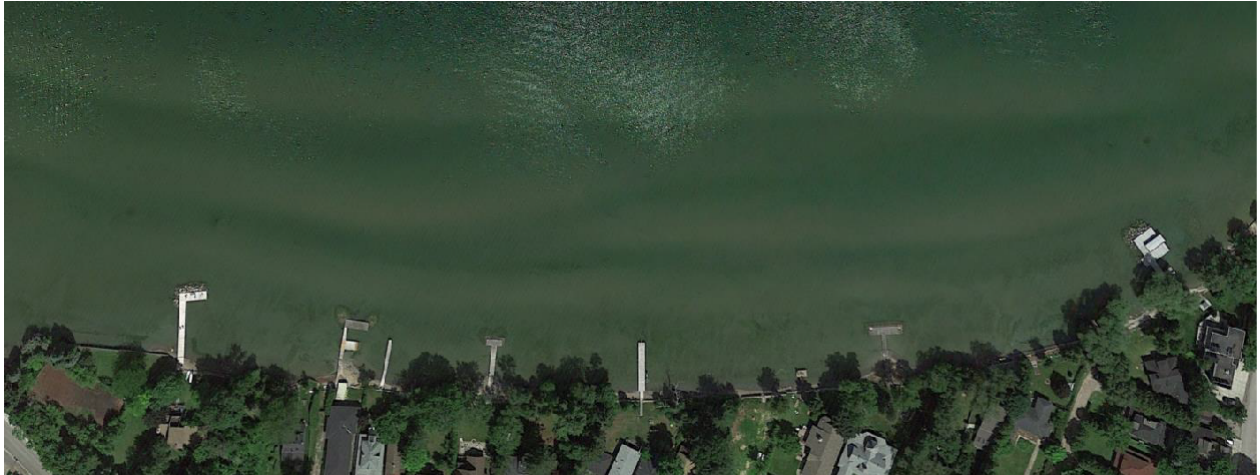
**Figure 9.5: Offshore Sand Bars and Offshore Breakwaters East of Georgina Beach**

In other regions of Lake Simcoe, there are more obvious sediment features in the nearshore, typically consisting of shore parallel sand bars. While most of these sandy areas do not have offshore breakwaters, there are some regions, such as the region just east of Georgina Beach (Figure 9.5) where some offshore breakwaters are present.

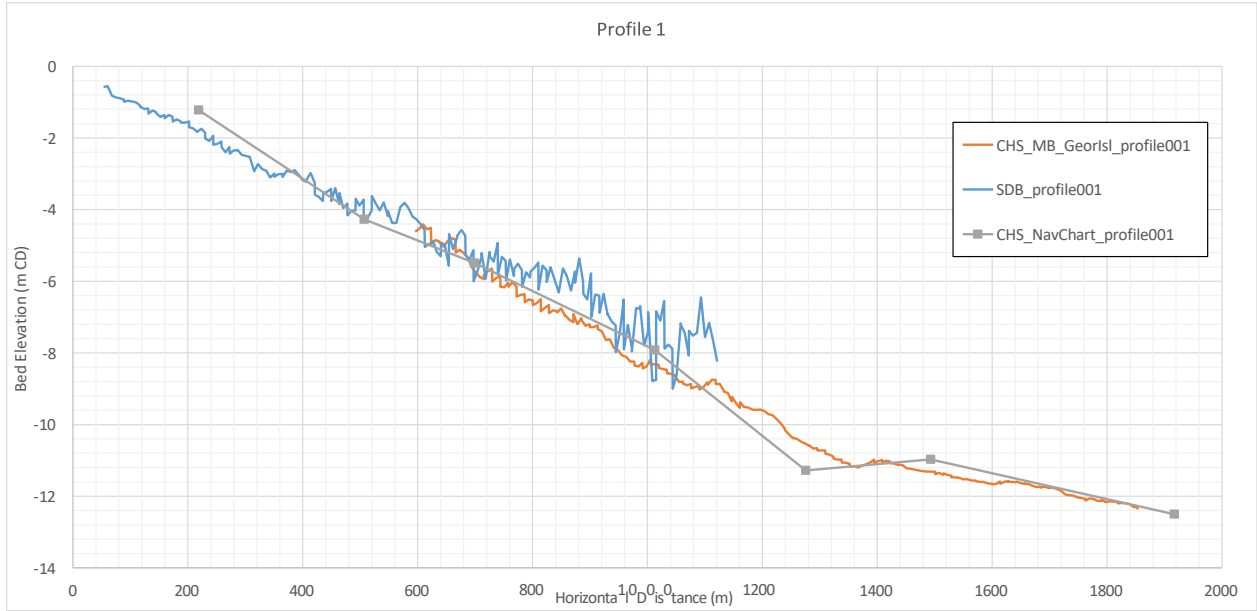
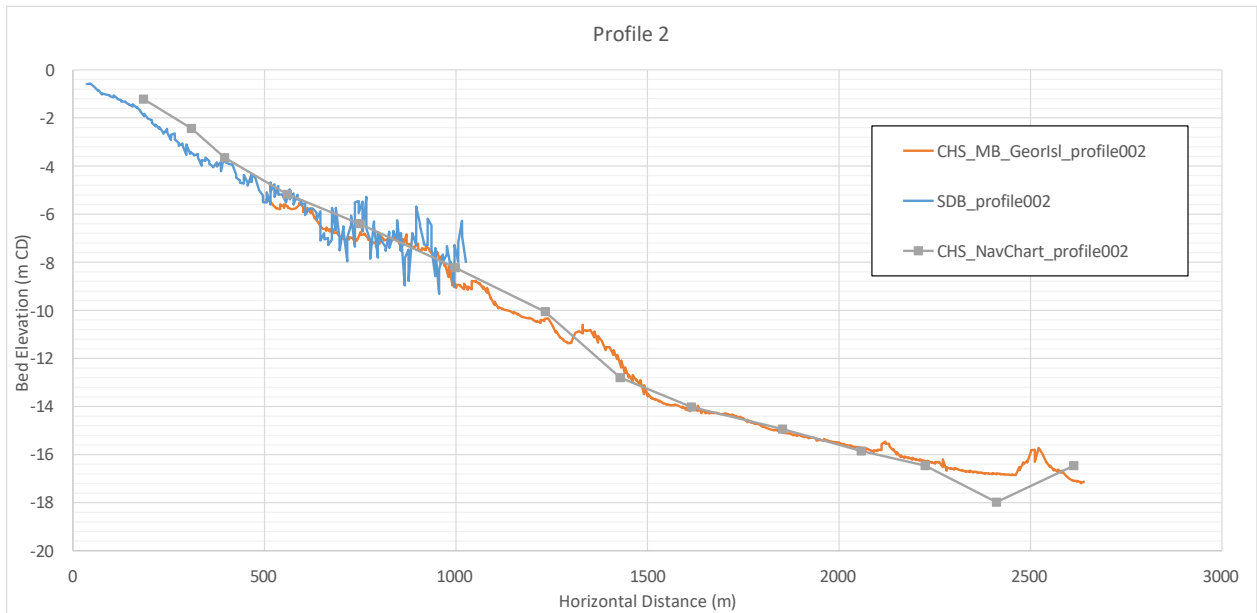
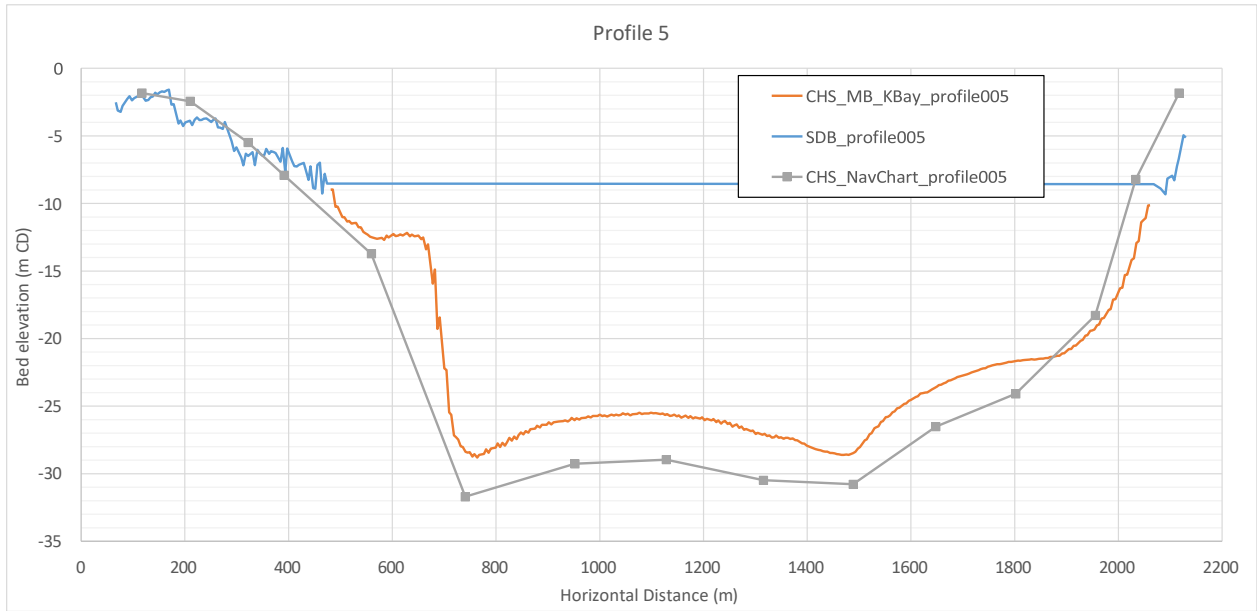
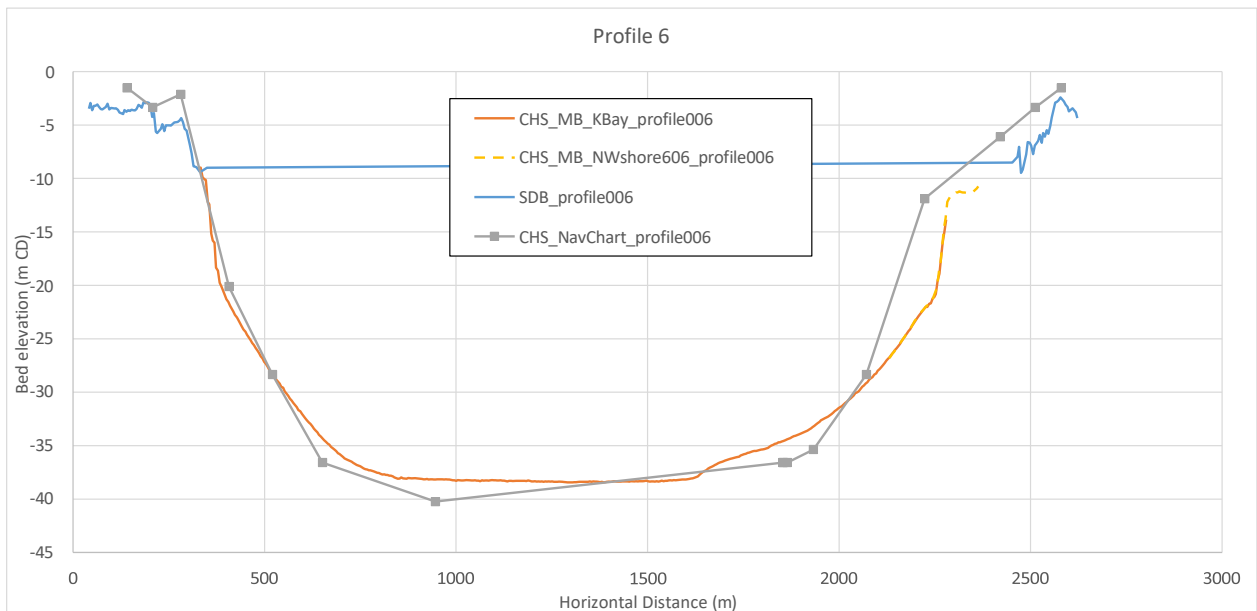
- CHS\_MB\* lines are Canadian Hydrographic Service Multi-Beam survey data
- CHS\_NavChart\* lines are from 1957 survey
- SDB\* lines are Satellite Derived Bathymetry
